Ground Up Home Inspections

Inspected By: Manny Theocharidis. Lic # 16000098512

Property Inspection Report

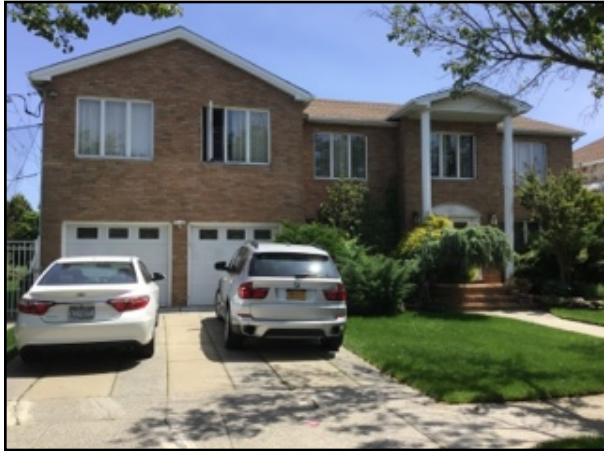
Figure 2-1

The exterior of the house is brick and vinyl siding and in marginal condition with defects noted.

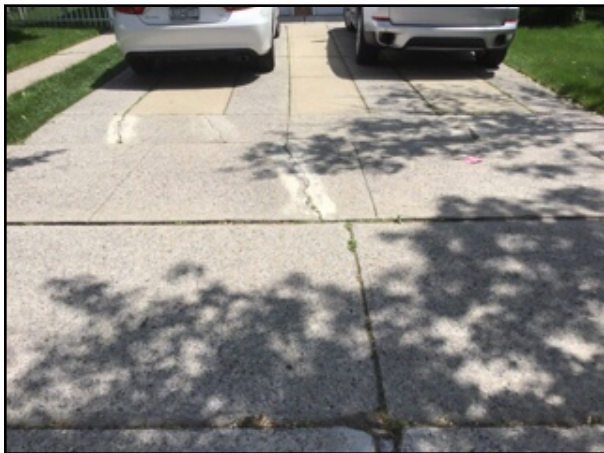
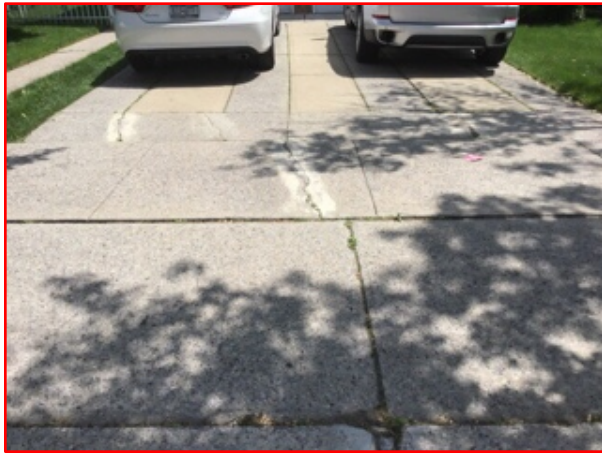
Figure 3-1

The front and side concrete walkway is in marginal condition as there are areas of concrete deterioration and cracking. Major tripping hazard. Recommend contacting a qualified mason to assess the situation and repair or replace as necessary.

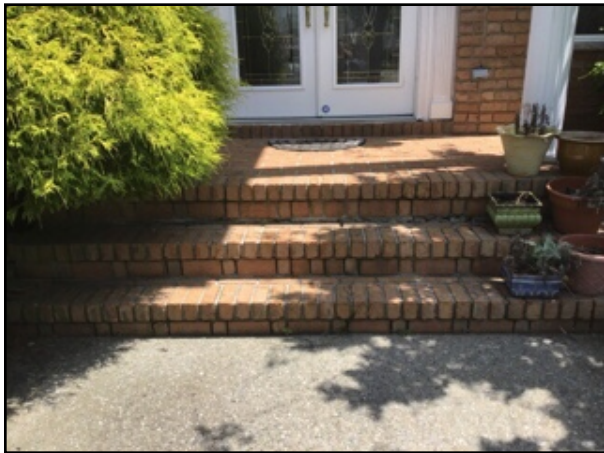
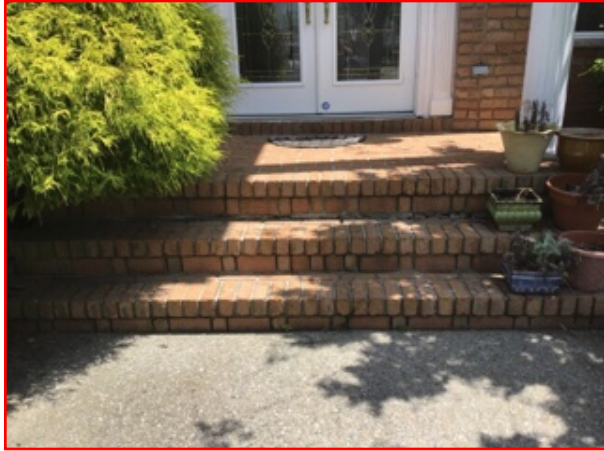
Figure 4-1

The front concrete steps are in marginal condition as some of the concrete has begun to crack and deteriorate, especially on the riser faces. Recommend hiring a qualified mason to repair as necessary so water and ice do not penetrate into the cement blocks and cause further damage.

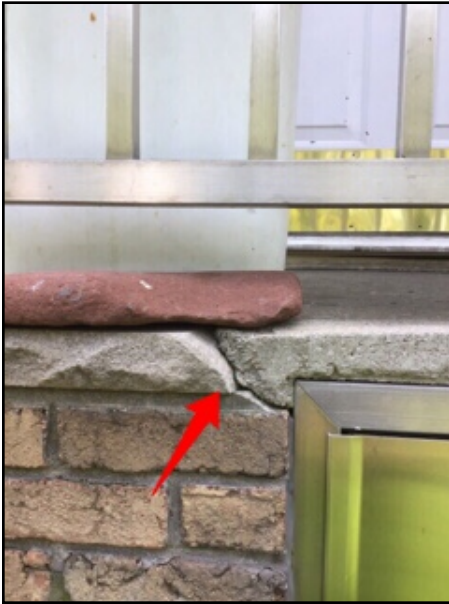
Figure 6-1

The entrance to the 2nd floor apartment concrete steps are in marginal condition as some of the concrete has begun to crack and deteriorate, especially on landing. Recommend hiring a qualified mason to repair as necessary so water and ice do not penetrate into the cement blocks and cause further damage.

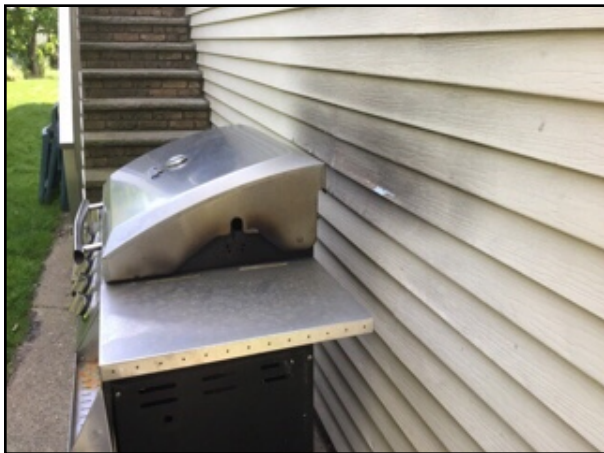
Figure 8-1

BBQ is too close to the vinyl siding of the house, which has lead to melting on the siding. Potential fire hazard. Recommend moving away from house.

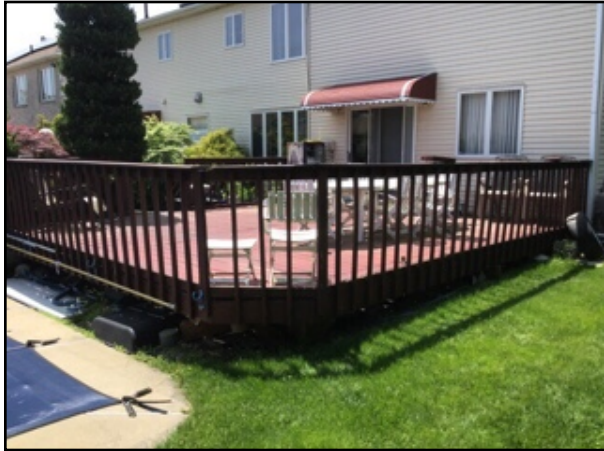
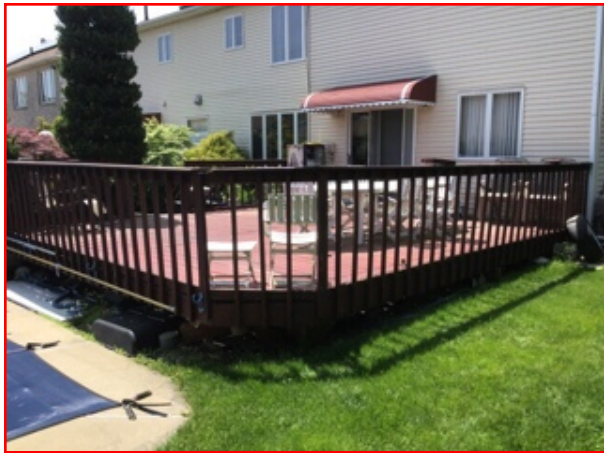
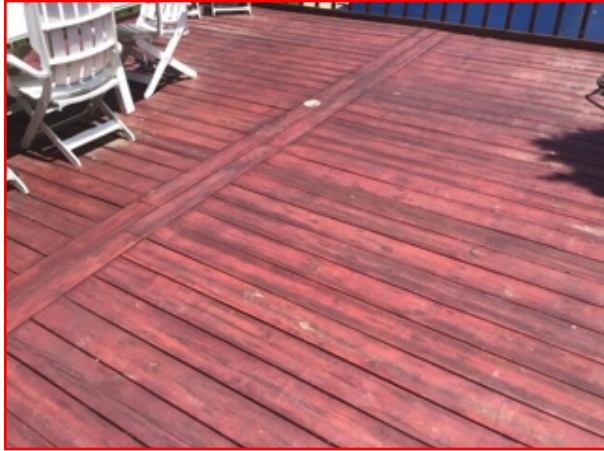
Figure 9-1

The hand and guard rails of the deck are in unsafe condition. The balusters are not spaced properly and are more than 4" apart which is a safety issue. The 2x6 support columns are undersized for this size and height deck. They should be 6"x6" and cross braced for anti swaying and support. Recommend hiring a licensed contractor to further evaluate.

5) The hand and guard rails of the deck are in unsafe condition. The balusters are not spaced properly and are more than 4" apart which is a safety issue. The 2x6 support columns are undersized for this size and height deck. They should be 6"x6" and cross braced for anti swaying and support. Recommend hiring a licensed contractor to further evaluate.

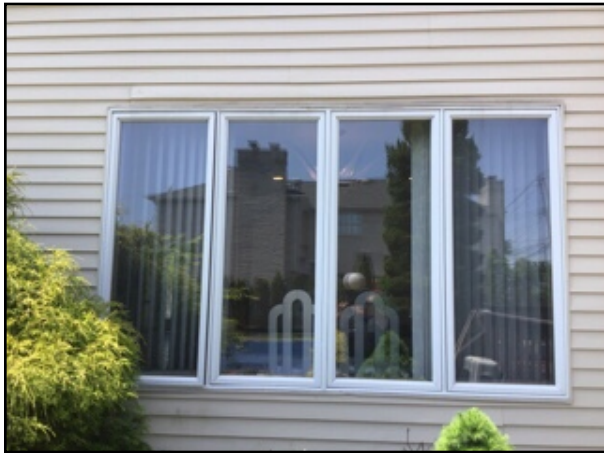
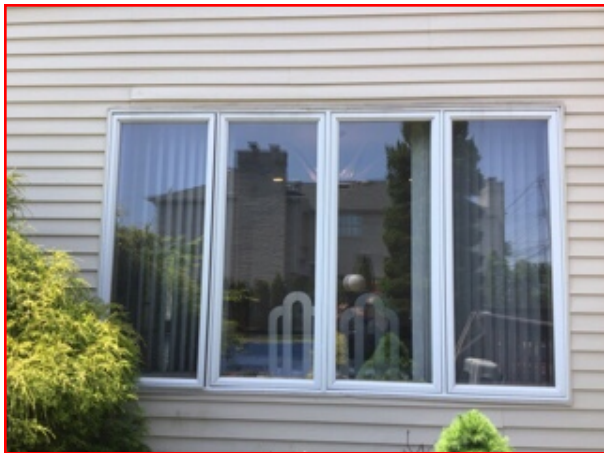
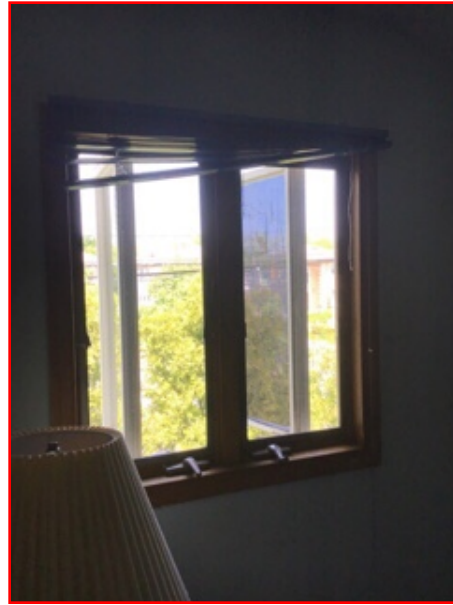
Figure 10-1

The windows in the house are older wood windows that do not open and close properly. (with/without external storms/screens attached). Recommend hiring a qualified contractor to replace with energy efficient thermo pane vinyl windows as necessary. On day day of inspection notice that all lintels on windows need to be sanded and painted to prevent deterioration. Recommend hiring a licensed contractor to further evaluate.

6) The windows in the house are older wood windows that do not open and close properly. (with/without external storms/screens attached). Recommend hiring a qualified contractor to replace with energy efficient thermo pane vinyl windows as necessary. On day day of inspection notice that all lintels on windows need to be sanded and painted to prevent deterioration. Recommend hiring a licensed contractor to further evaluate.

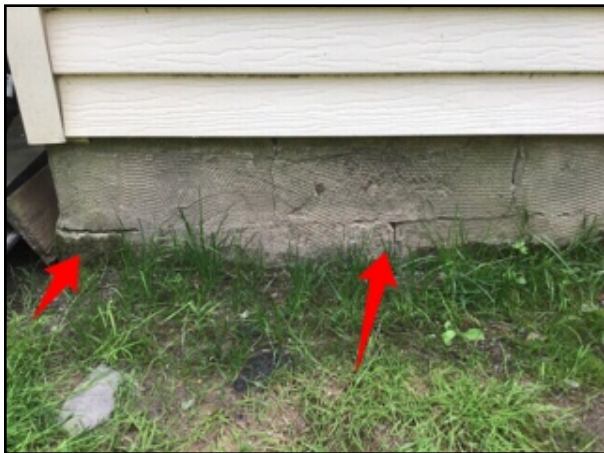
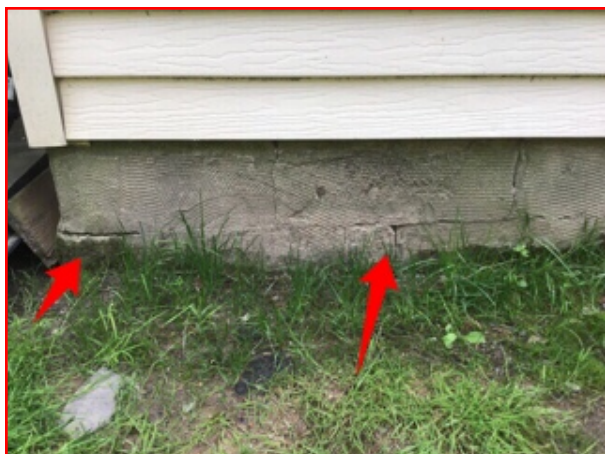
Figure 13-1

The bottom section of the chimney mortar and blocks are separated. Exterior of chimney is covered with vinyl siding, do not know extent of damage. Recommend hiring a licensed contractor to further inspect.

9) The bottom section of the chimney mortar and blocks are separated. Exterior of chimney is covered with vinyl siding, do not know extent of damage. Recommend hiring a licensed contractor to further inspect.

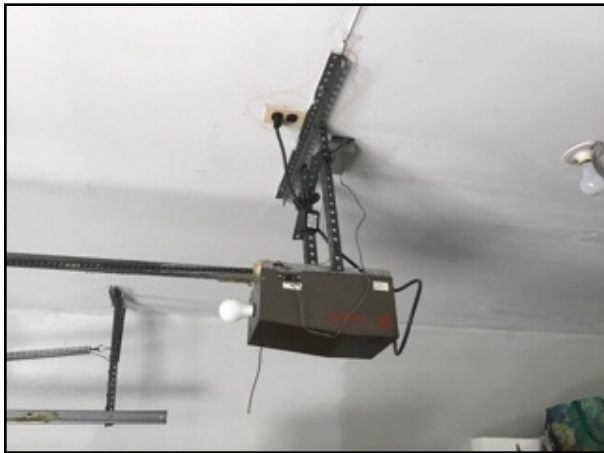
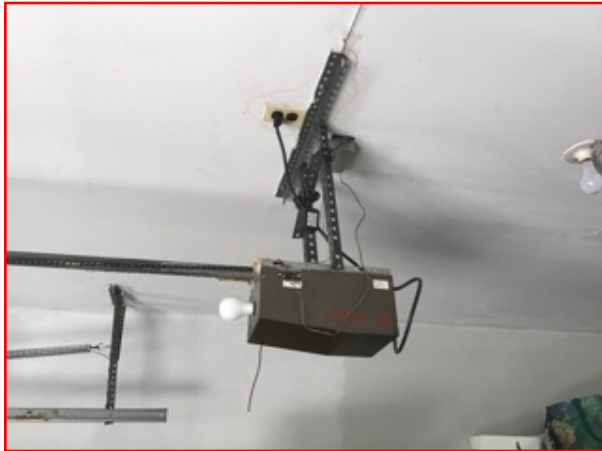
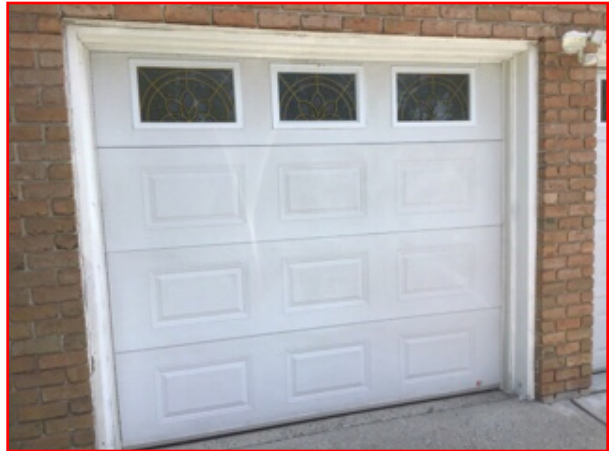
Figure 16-1

The left garage door opened and closed properly but does not have an auto reverse safety feature such as photo eyes. Recommend hiring a qualified overhead door company to assess and install a new opener with this feature if this feature cannot be added to the existing opener.

10) The left garage door opened and closed properly but does not have an auto reverse safety feature such as photo eyes. Recommend hiring a qualified overhead door company to assess and install a new opener with this feature if this feature cannot be added to the existing opener.

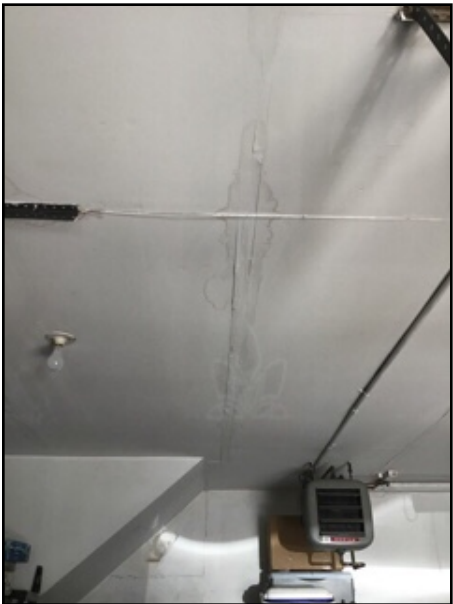
Figure 17-1

Comment 17:
Ceiling in garage has old water stains. Taping and Sheetrock joints have separated. Recommend hiring a licensed contractor to repair.

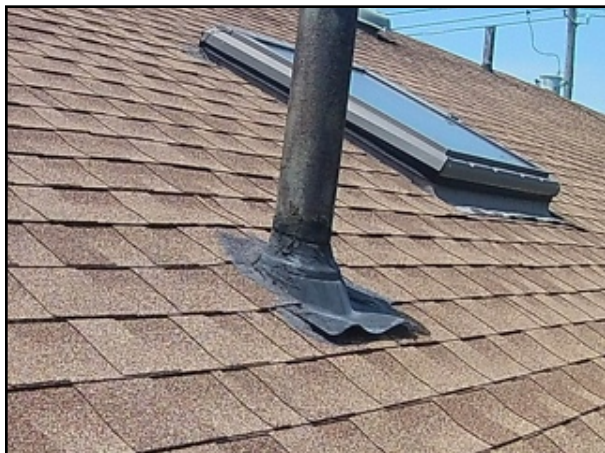
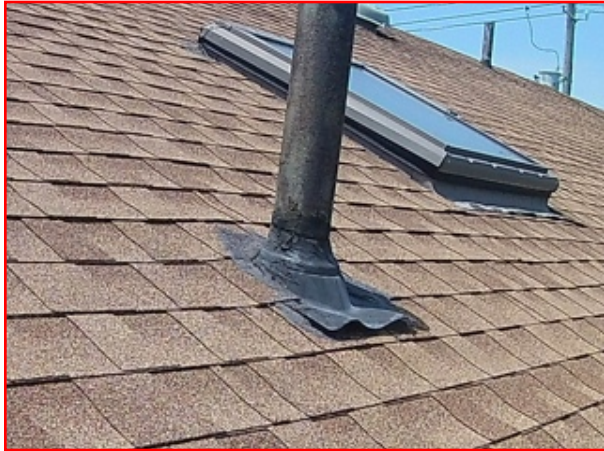
Figure 19-1

The plumbing vent boot needs to be repaired or replaced. Recommend hiring a licensed contractor to repair.

12) The plumbing vent boot needs to be repaired or replaced. Recommend hiring a licensed contractor to repair.

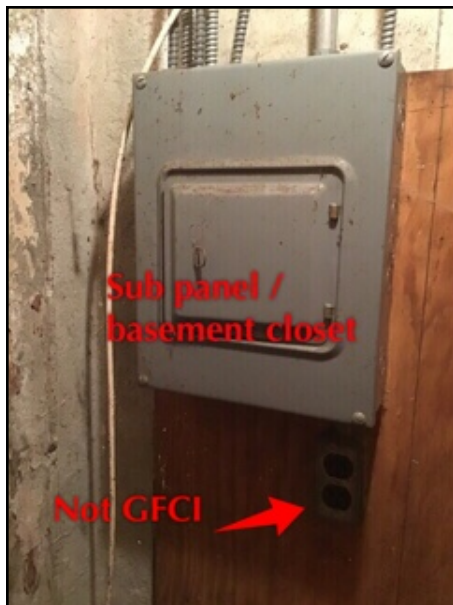
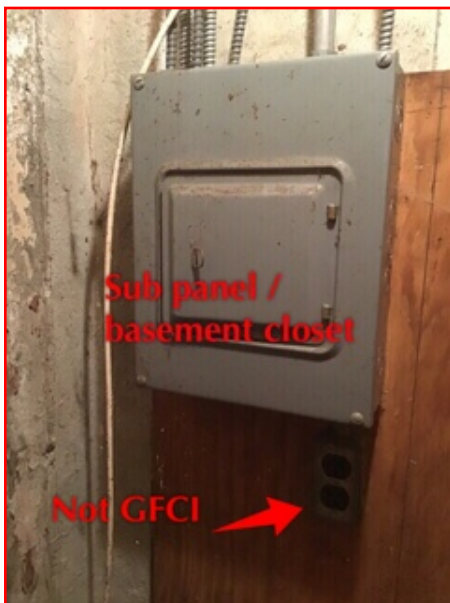
Figure 27-1

Recommend replacing outlet with GFCI. Recommend hiring a licensed electrical contractor to replace.

15) Recommend replacing outlet with GFCI. Recommend hiring a licensed electrical contractor to replace.

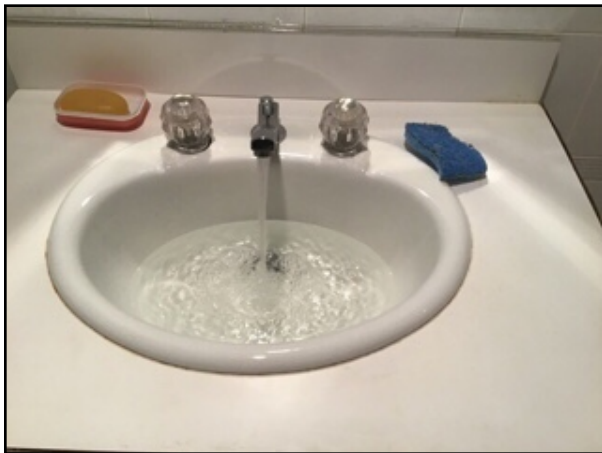
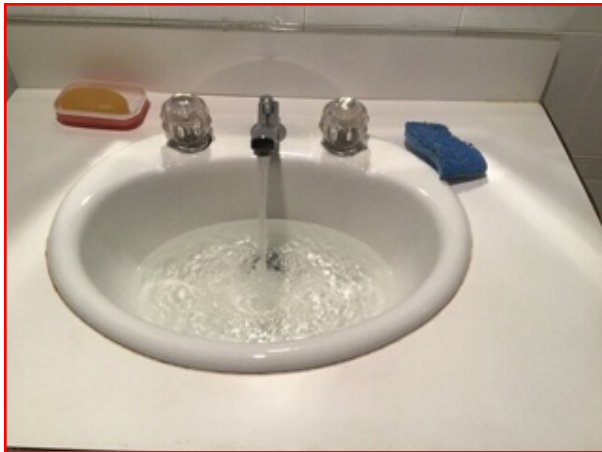
Figure 36-1

The basement bathroom was in working condition with no leaks noted at the sink, toilet or tub/shower. The GFCI outlet was tested and operated properly on the date of inspection. There was a exhaust fan for ventilation and no mold or mildew was noted on the walls or ceiling. Sink is backed up defect noted.

Basement bathroom sink is clogged. Recommend hiring a licensed plumber to repair.

20) Basement bathroom sink is clogged. Recommend hiring a licensed plumber to repair.

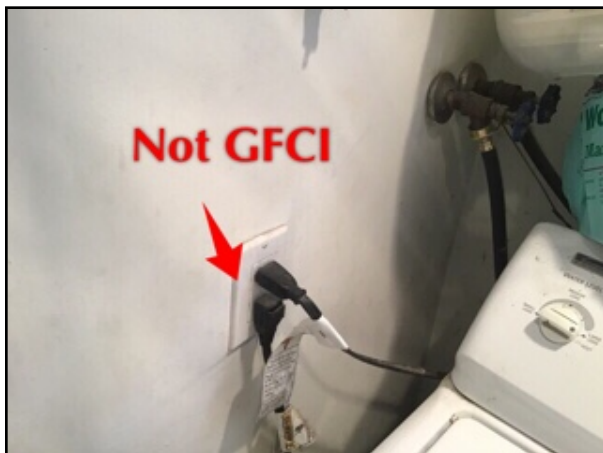
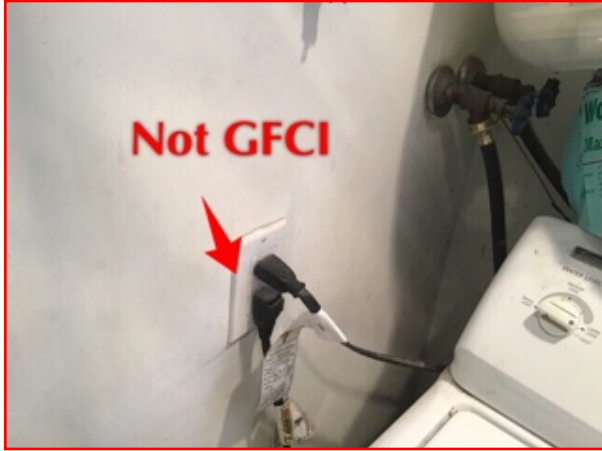
Figure 40-1

The outlet in the laundry area was not a GFCI outlet and is a safety hazard as it is directly below/next to the water supply lines. Recommend hiring a licensed electrician to replace the existing outlet with a GFCI outlet as necessary.

21) The outlet in the laundry area was not a GFCI outlet and is a safety hazard as it is directly below/next to the water supply lines. Recommend hiring a licensed electrician to replace the existing outlet with a GFCI outlet as necessary.

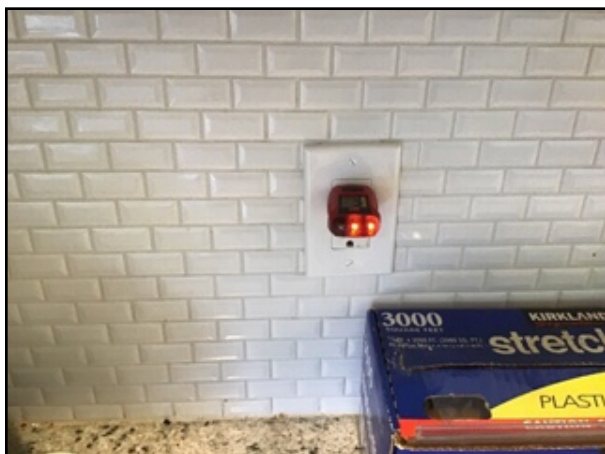
Figure 43-1

The outlets in the kitchen counter top area are not GFCI protected and this is a safety hazard. Recommend hiring a licensed electrician to replace all outlets within 6' of the sink with GFCI outlets.

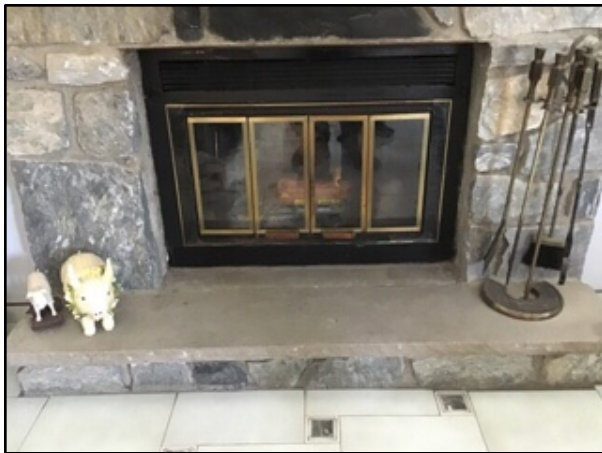
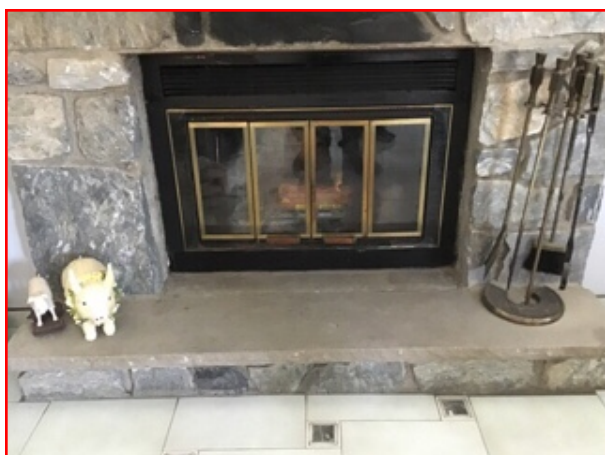
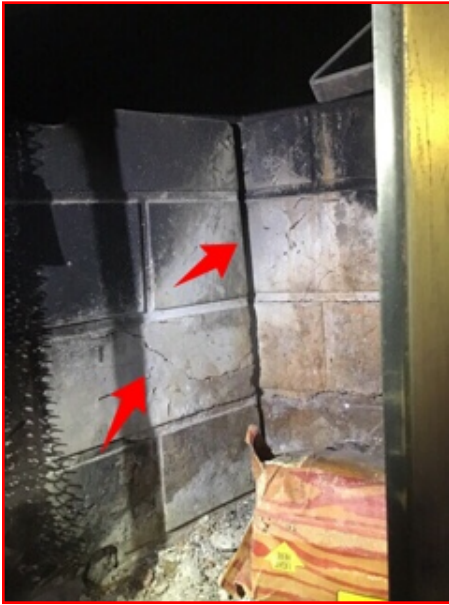
Figure 45-1

The fireplace is in poor condition with cracks and missing mortar in the fire box. It is ALWAYS recommended to have the flue inspected and cleaned prior to use. Recommend hiring a qualified mason or chimney contractor to assess and repair as necessary.

24) The fireplace is in poor condition with cracks and missing mortar in the fire box. It is ALWAYS recommended to have the flue inspected and cleaned prior to use. Recommend hiring a qualified mason or chimney contractor to assess and repair as necessary.

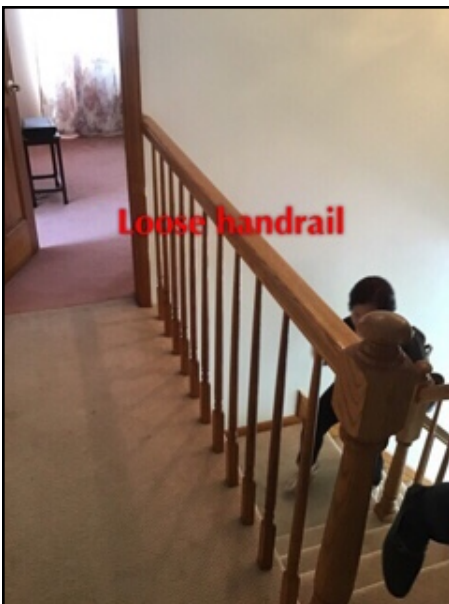
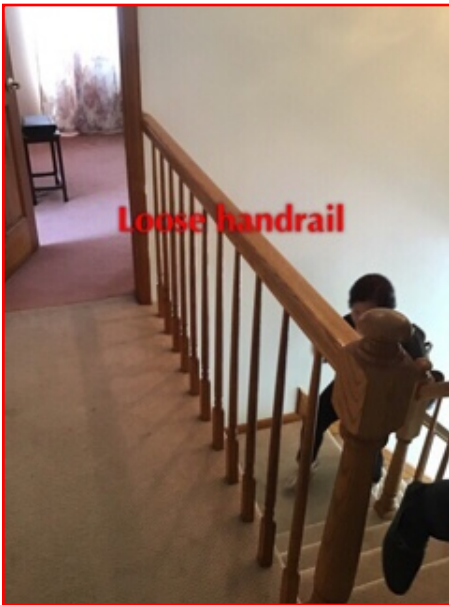
Figure 47-1

Comment 47:
The 2nd floor landing has a loose handrail.

25) The 2nd floor landing has a loose handrail.

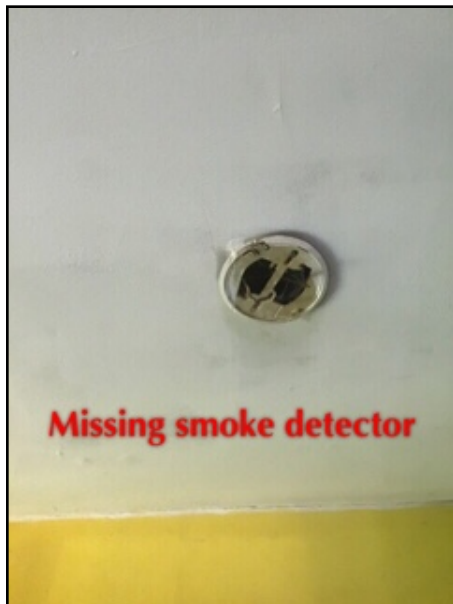
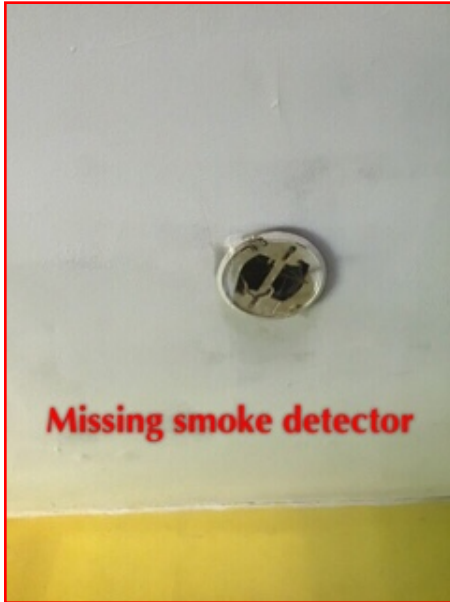
Figure 50-1

Smoke or carbon monoxide detectors were not present in the unit and this is a safety hazard recommend installing prior to moving in.

26) Smoke or carbon monoxide detectors were not present in the unit and this is a safety hazard recommend installing prior to moving in.

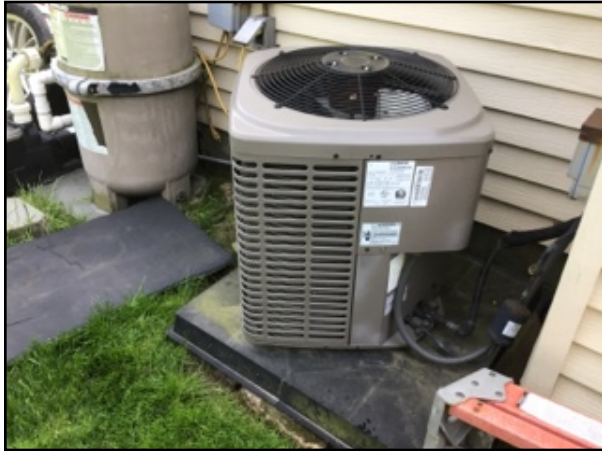
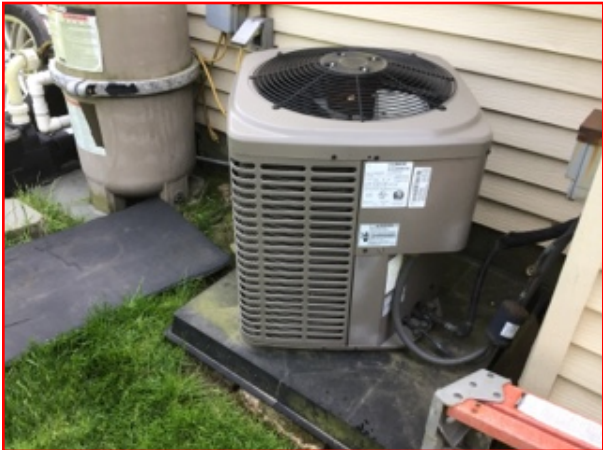
Figure 52-1

The air conditioning system was tested and did not operate properly on the date of inspection. Discharge temperature was higher than the thermostat set point. It is recommended to have proper servicing done annually to ensure maximum efficiency. The refrigerant lines and electrical disconnects were noted and in marginal condition.

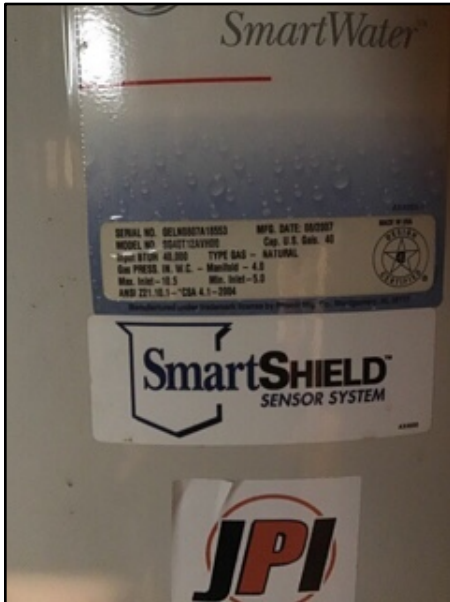
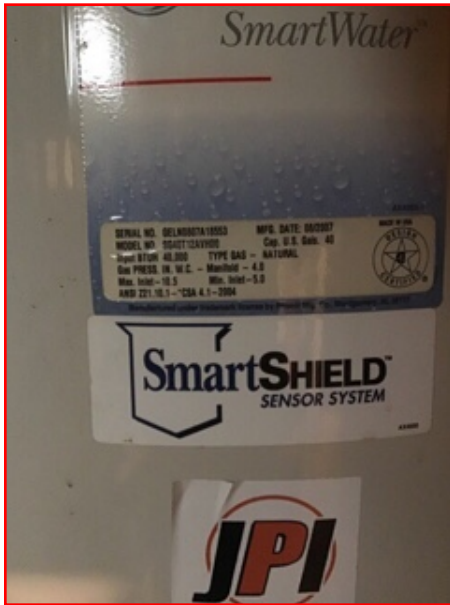
Figure 53-1

The 2nd floor hot water tank is a gas heated tank made by GE and is 15 years old. The unit is past its life expectancy. Recommend hiring a licensed plumber to replace the tank and pipe fittings where corroded.

28) The 2nd floor hot water tank is a gas heated tank made by GE and is 15 years old. The unit is past its life expectancy. Recommend hiring a licensed plumber to replace the tank and pipe fittings where corroded.

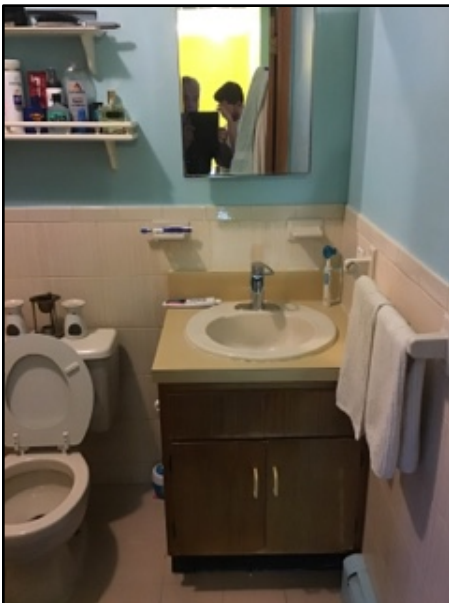
Figure 54-1

The main bath was in working condition with no leaks noted at the sink, toilet or tub/shower. The GFCI outlet was tested and operated properly on the date of inspection. There was an exhaust fan for ventilation and mildew was noted on the walls in tub area.

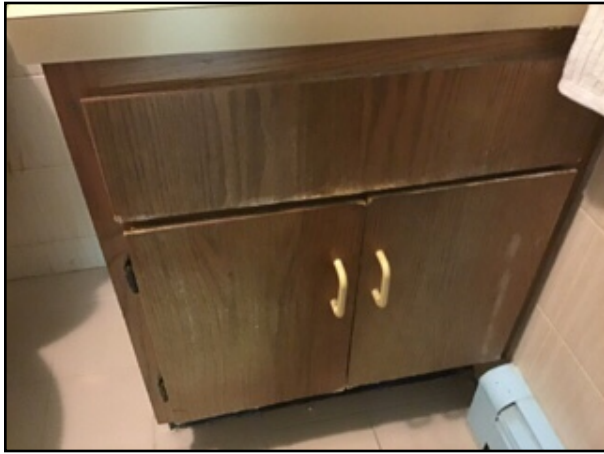
Figure 55-1

Comment 55:
Bathroom vanity shows signs of aging. Recommend replacement.

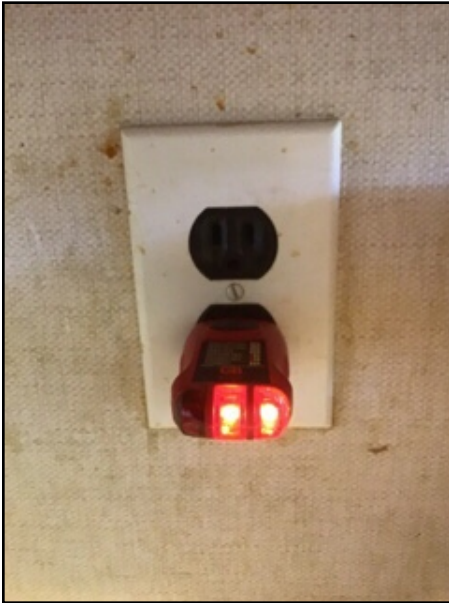
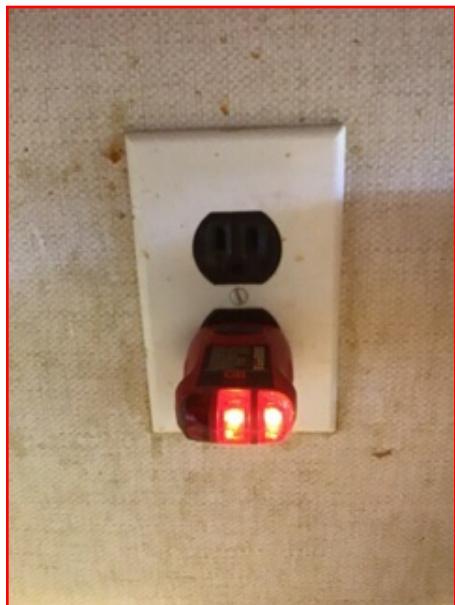
Figure 58-1

The outlets in the kitchen sink area are not GFCI protected and this is a safety hazard. Recommend hiring a licensed electrician to replace all outlets within 6' of the sink with GFCI outlets.

30) The outlets in the kitchen sink area are not GFCI protected and this is a safety hazard. Recommend hiring a licensed electrician to replace all outlets within 6' of the sink with GFCI outlets.

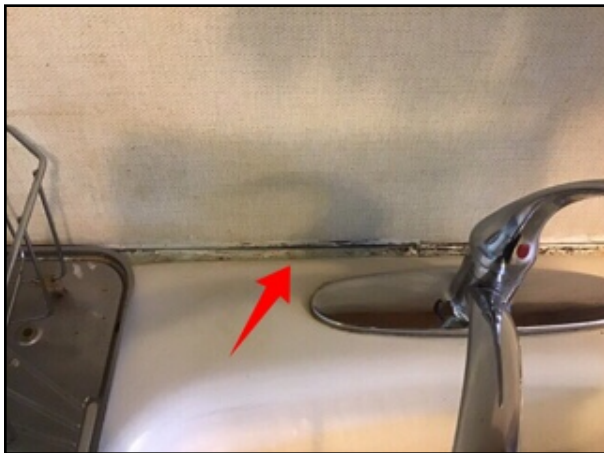
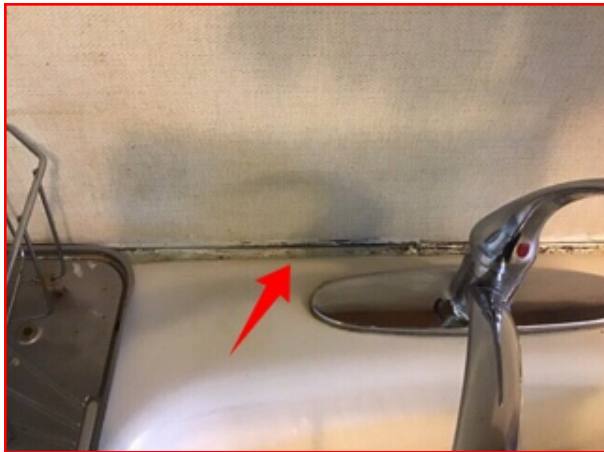
Figure 60-1

Comment 60:
Missing caulking behind kitchen faucet. Recommend repair to prevent water penetration.

32) Missing caulking behind kitchen faucet. Recommend repair to prevent water penetration.

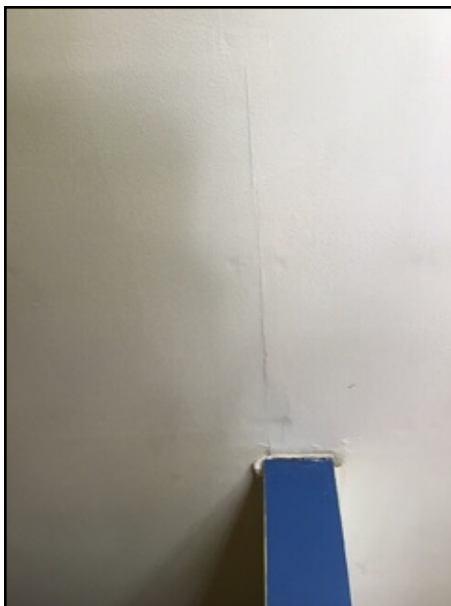
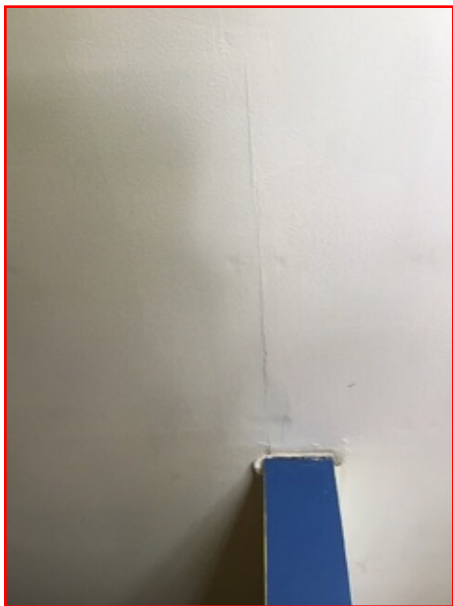
Figure 63-1

The ceiling has multiple cracks. Recommend hiring a licensed contractor to repair.

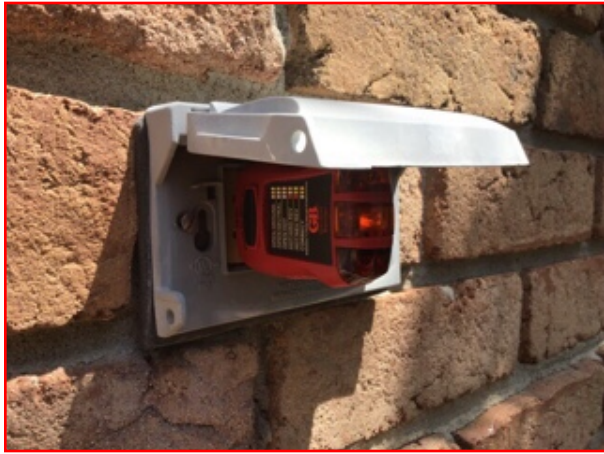
Figure 7-1

The ground fault circuit interrupter (GFCI) outlet is dead or there is no power to outlet located in front entrance. Recommend hiring a licensed electrical contractor to repair.

4) The ground fault circuit interrupter (GFCI) outlet is dead or there is no power to outlet located in front entrance. Recommend hiring a licensed electrical contractor to repair.

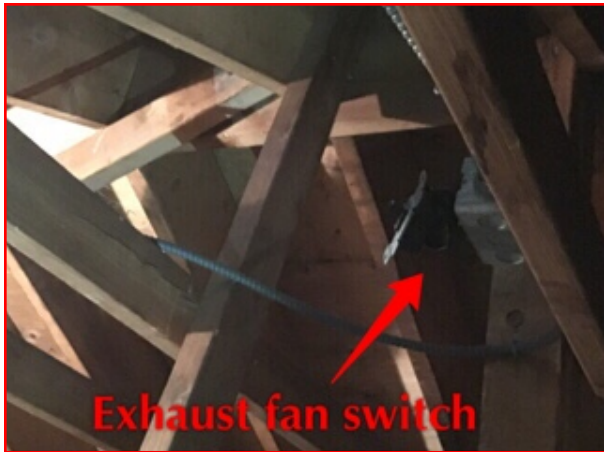
Figure 23-1

Attic exhaust vent switch not properly installed. Recommend hiring a licensed electrical contractor to repair.

13) Attic exhaust vent switch not properly installed. Recommend hiring a licensed electrical contractor to repair.

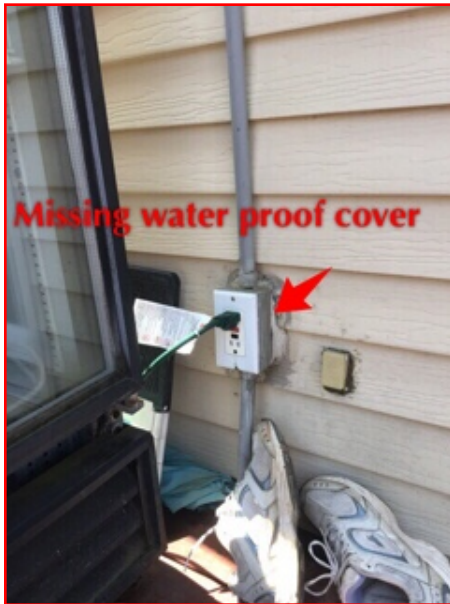
Figure 26-1

All outlets on the exterior of the house and garage should be GFCI outlets for safety purposes. Recommend hiring a licensed electrician to test and replace all exterior and garage outlets with GFCI outlets and install proper covers on the exterior ones if necessary.

14) All outlets on the exterior of the house and garage should be GFCI outlets for safety purposes. Recommend hiring a licensed electrician to test and replace all exterior and garage outlets with GFCI outlets and install proper covers on the exterior ones if necessary.

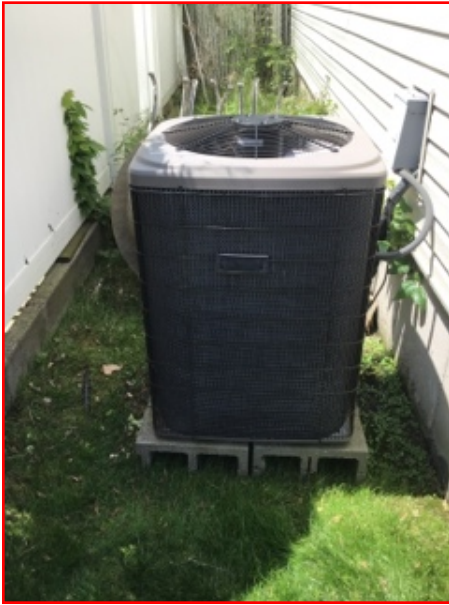
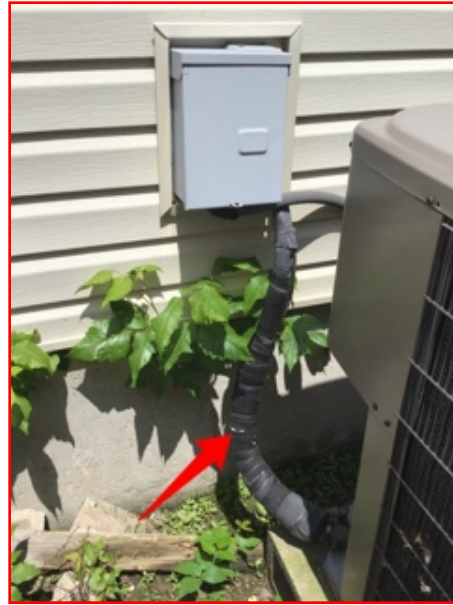
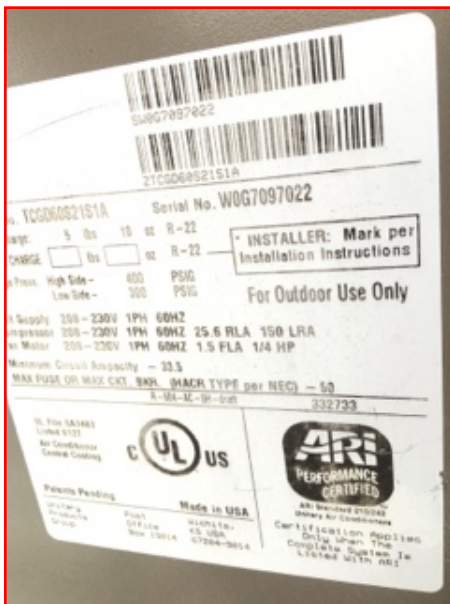
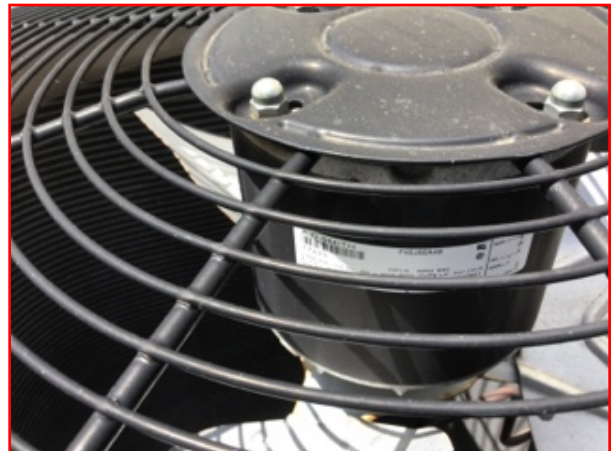
The exterior compressor unit is showing signs of age and is rusted. The refrigerant line installation is worn and frayed and should be replaced. The cinderblocks need to be replaced with a concrete pad. Recommend having a licensed HVAC company come check the exterior condenser unit and replace insulation on the refrigerant line. Unit was not working on day of inspection.

17) The exterior compressor unit is showing signs of age and is rusted. The refrigerant line installation is worn and frayed and should be replaced. The cinderblocks need to be replaced with a concrete pad. Recommend having a licensed HVAC company come check the exterior condenser unit and replace insulation on the refrigerant line. Unit was not working on day of inspection.

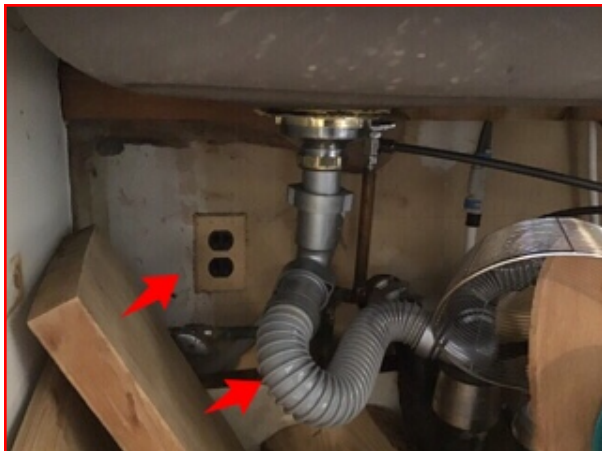
Figure 42-1

The outlets in the kitchen sink area are not GFCI protected and this is a safety hazard. Recommend hiring a licensed electrician to replace all outlets within 6' of the sink with GFCI outlets. Recommend replacement of flex pipe with aluminum p-trap pipe. Recommend hiring a licensed plumber for further evaluation.

22) The outlets in the kitchen sink area are not GFCI protected and this is a safety hazard. Recommend hiring a licensed electrician to replace all outlets within 6' of the sink with GFCI outlets. Recommend replacement of flex pipe with aluminum p-trap pipe. Recommend hiring a licensed plumber for further evaluation.
