Ground Up Home Inspections

Inspected By: Manny Theocharidis. Lic # 16000098512

Property Inspection Report

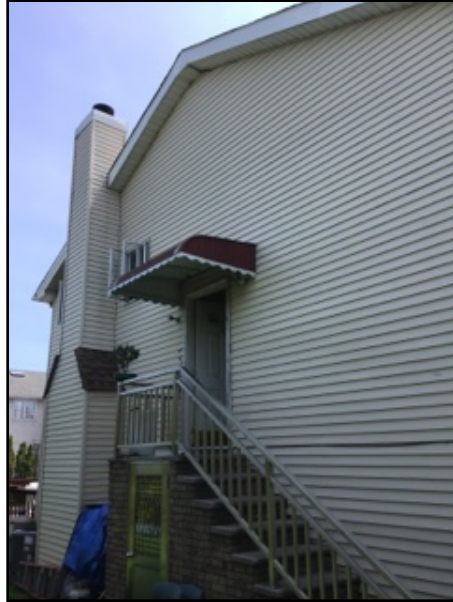
Figure 2-2

The exterior of the house is brick and vinyl siding and in marginal condition with defects noted.

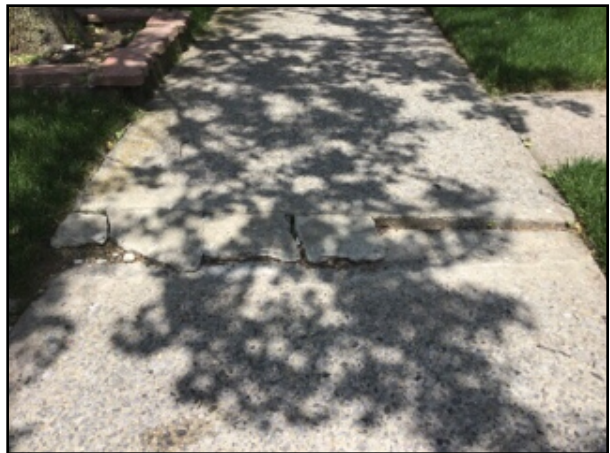
Figure 3-2

The front and side concrete walkway is in marginal condition as there are areas of concrete deterioration and cracking. Major tripping hazard. Recommend contacting a qualified mason to assess the situation and repair or replace as necessary.

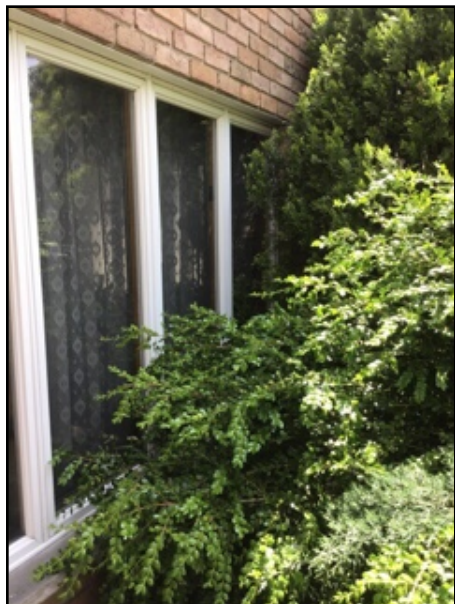
Figure 5-1

Shrub and tree growth are not far enough away from the sides of the house.
Regular maintenance and pruning should be done to prevent contact in the future.

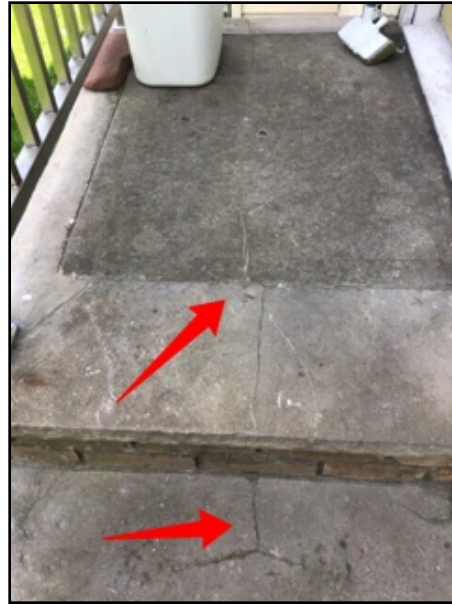
Figure 6-2

The entrance to the 2nd floor apartment concrete steps are in marginal condition as some of the concrete has begun to crack and deteriorate, especially on landing. Recommend hiring a qualified mason to repair as necessary so water and ice do not penetrate into the cement blocks and cause further damage.

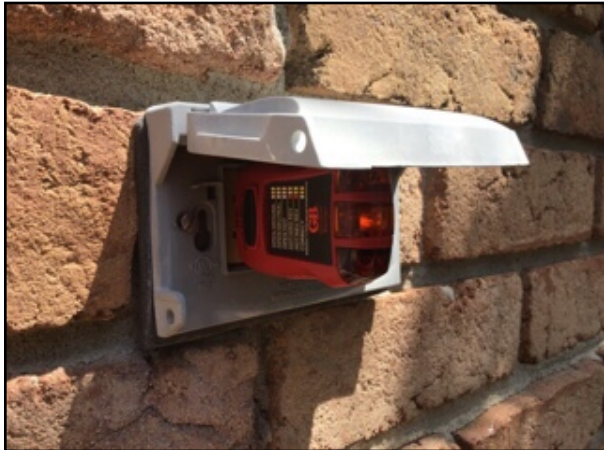
Figure 7-1

The ground fault circuit interrupter (GFCI) outlet is dead or there is no power to outlet located in front entrance. Recommend hiring a licensed electrical contractor to repair.

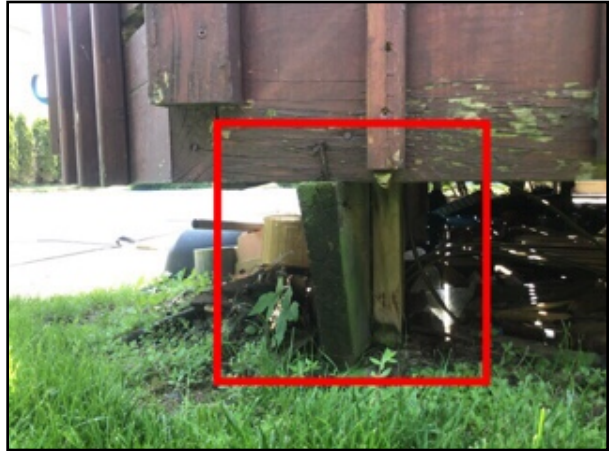
Figure 9-2

The hand and guard rails of the deck are in unsafe condition. The balusters are not spaced properly and are more than 4" apart which is a safety issue. The 2x6 support columns are undersized for this size and height deck. They should be 6"x6" and cross braced for anti swaying and support. Recommend hiring a licensed contractor to further evaluate.

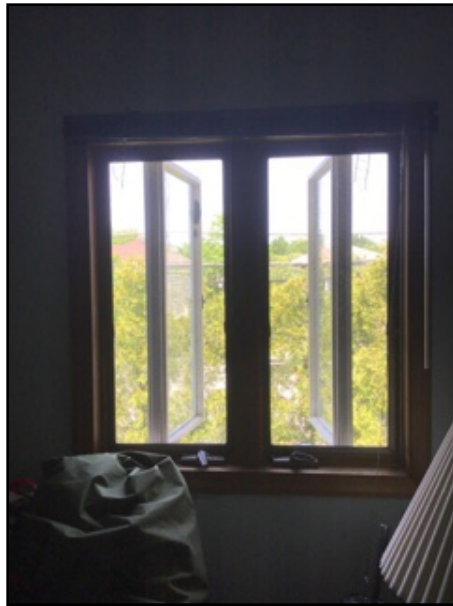
Figure 10-2

The windows in the house are older wood windows that do not open and close properly. (with/without external storms/screens attached). Recommend hiring a qualified contractor to replace with energy efficient thermo pane vinyl windows as necessary. On day day of inspection notice that all lintels on windows need to be sanded and painted to prevent deterioration. Recommend hiring a licensed contractor to further evaluate.

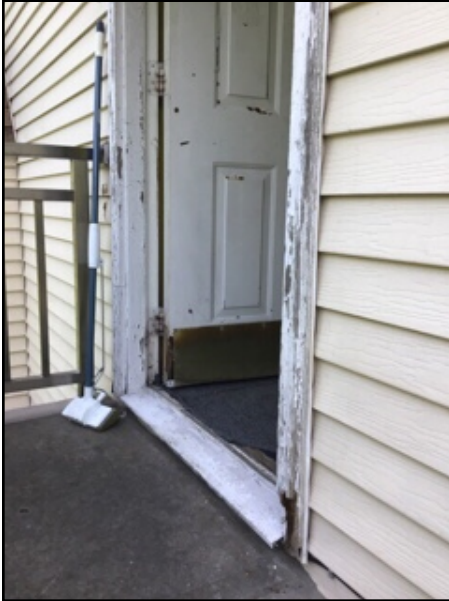
Figure 11-1

The second floor entry door is in need of repair as there is wood damage and it needs to be repaired or replaced. Recommend hiring a qualified contractor to assess and repair as necessary.

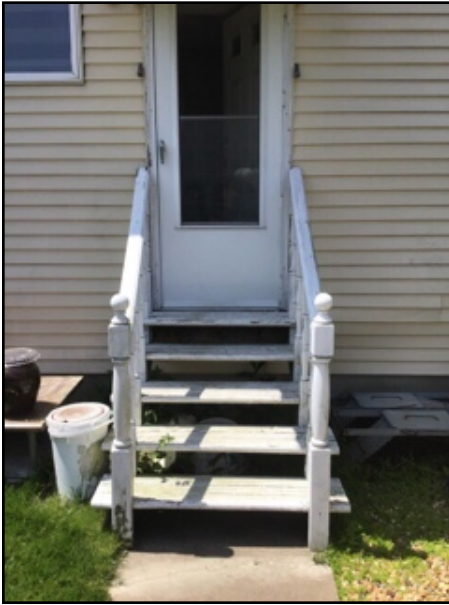
Figure 12-1

The rear steps are in an marginal condition as they are loose and wobbly. Signs of deterioration. Recommend hiring a qualified contractor to assess and repair as necessary.

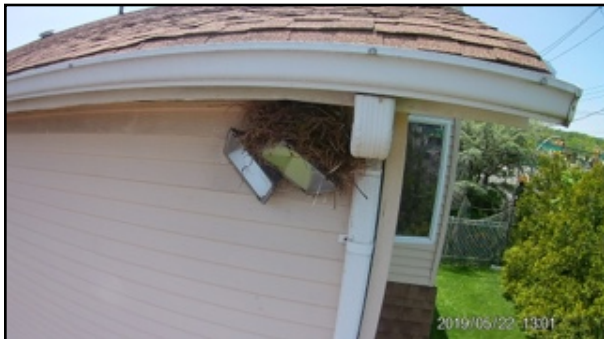
Figure 14-1

Comment 14:
Birds nest in rear top right corner of house.

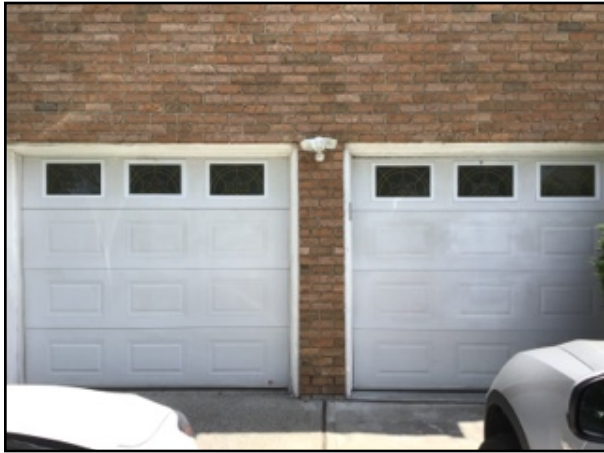
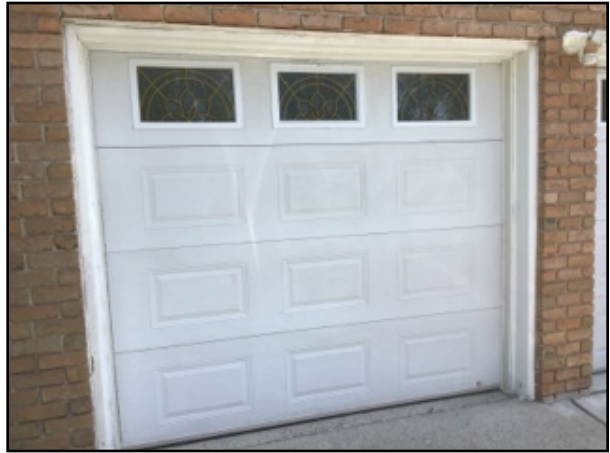
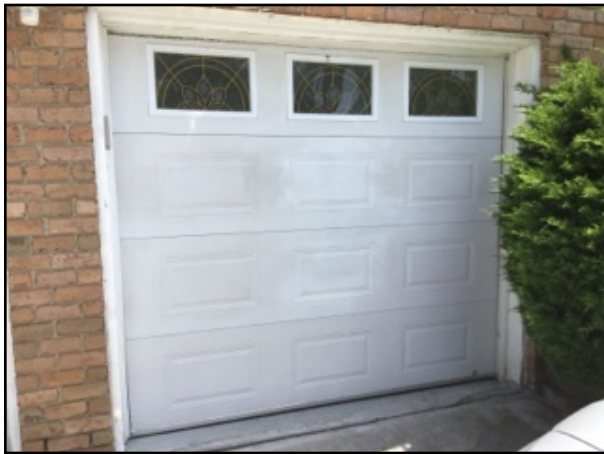
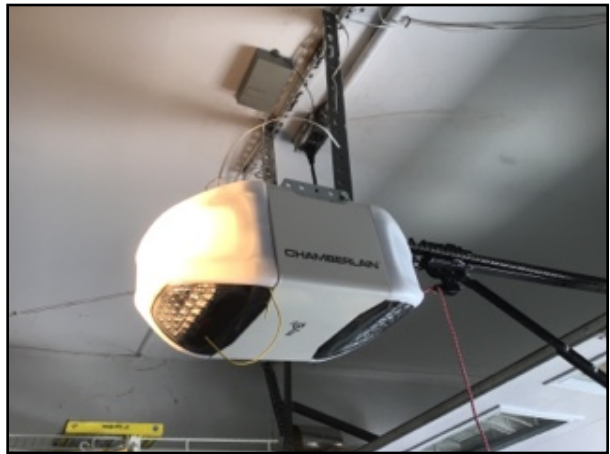
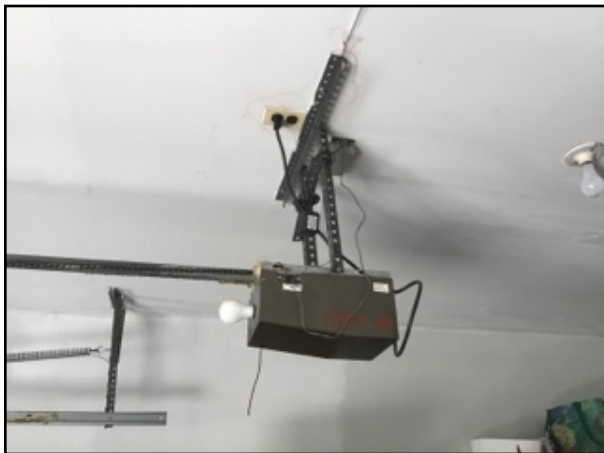
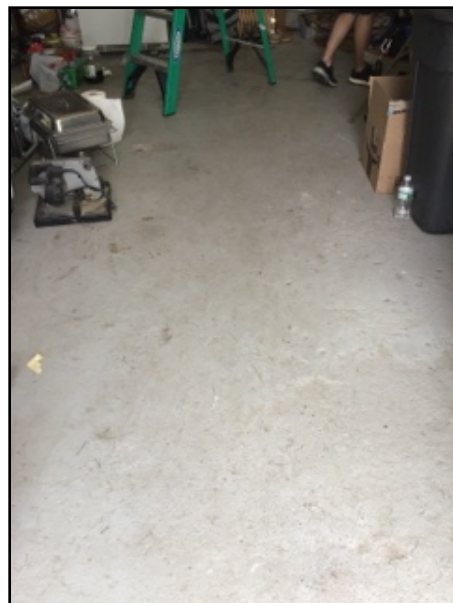
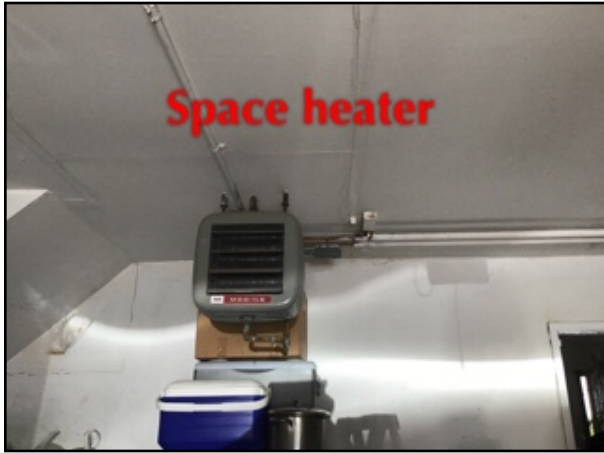
Comment 15:
The garage is a two car garage with overhead openers. The garage is fully sheet rocked with defects noted. The concrete slab has no major defects. The garage door openers were tested with no defects noted. The photo sensor and stop pad on the right garage door was tested with no defects noted. No photo sensor and no stop pad on left garage door.

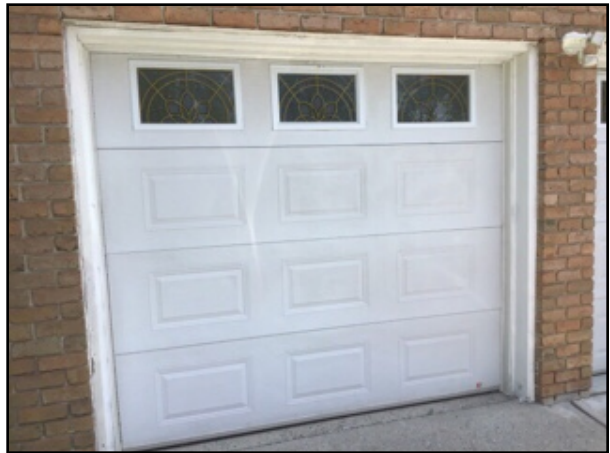
Figure 16-2

The left garage door opened and closed properly but does not have an auto reverse safety feature such as photo eyes. Recommend hiring a qualified overhead door company to assess and install a new opener with this feature if this feature cannot be added to the existing opener.

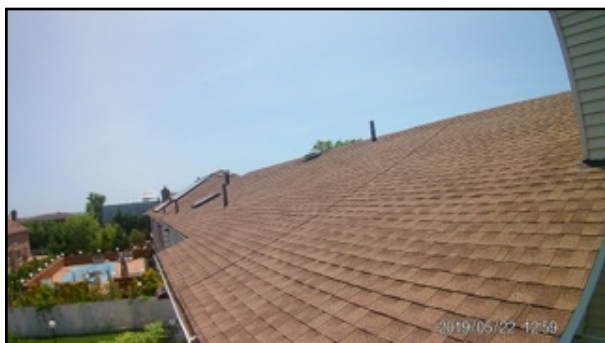
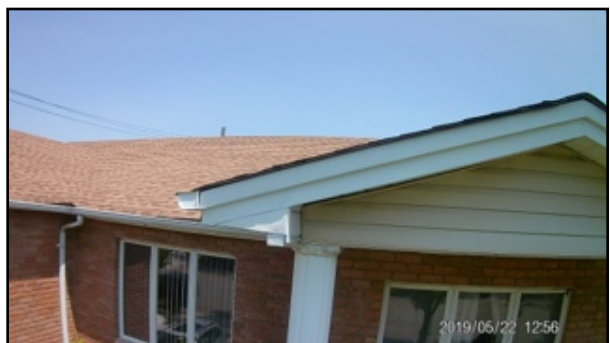
The plumbing vent boot needs to be repaired or replaced. Recommend hiring a licensed contractor to repair.

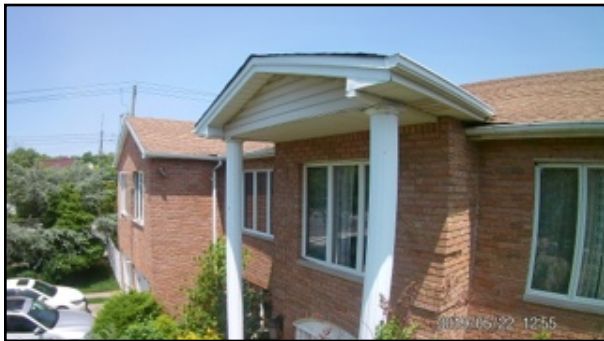
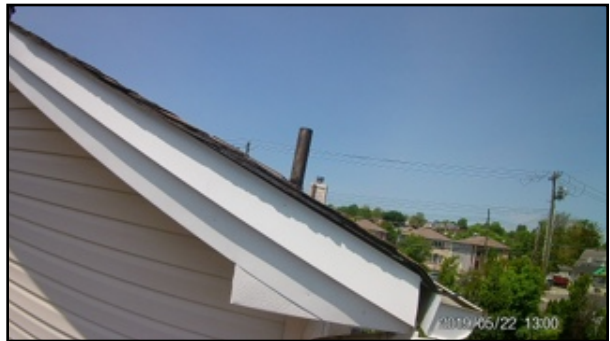
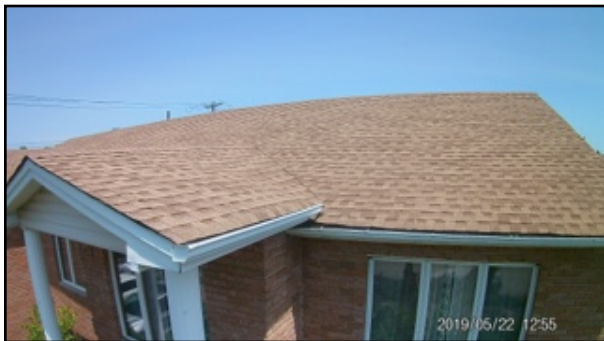
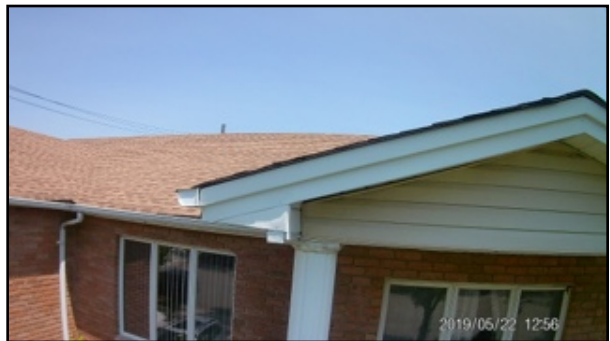
The fascias and soffits are comprised of maintenance-free vinyl and aluminum and are in adequate condition. It is important to immediately repair any soffit or fascia materials that may become loose or dislodged to prevent water and ice from getting behind these surfaces and causing damage to any wood products. The gutters are aluminum and appear to be working properly to divert rain water away from the garage as there are no signs of excess moisture in the interior of the garage being caused by improper gutters. Recommend keeping gutters free and clear of debris and leaves.

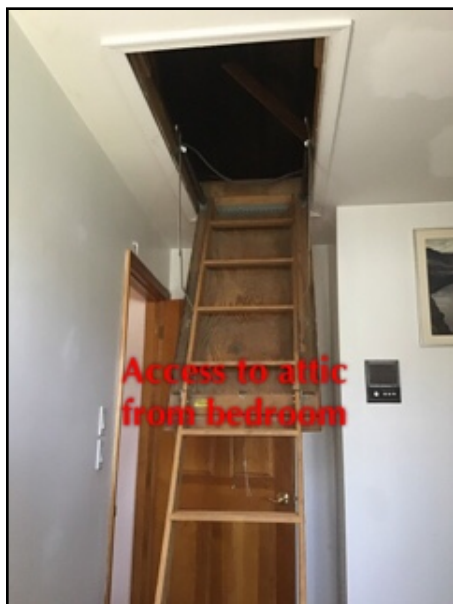
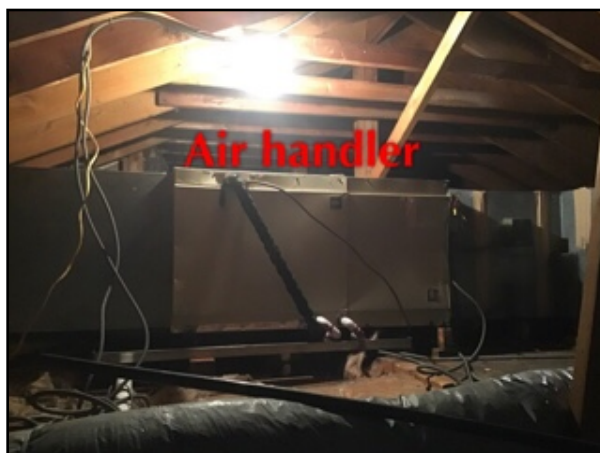
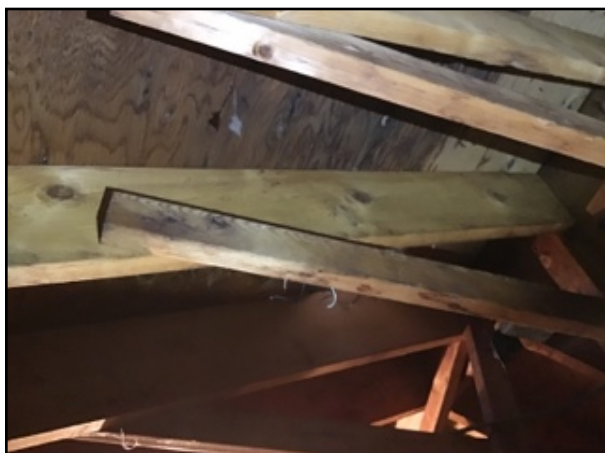
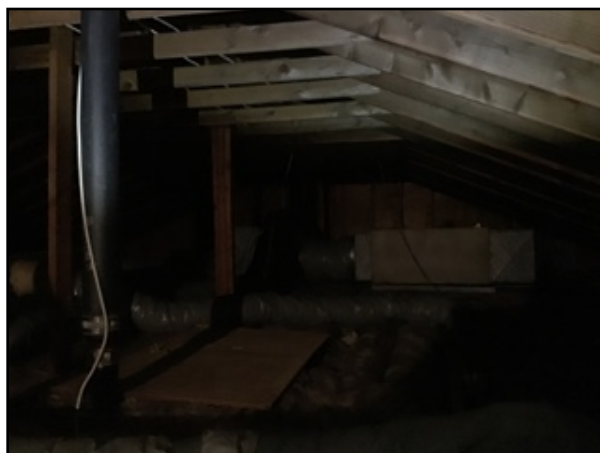
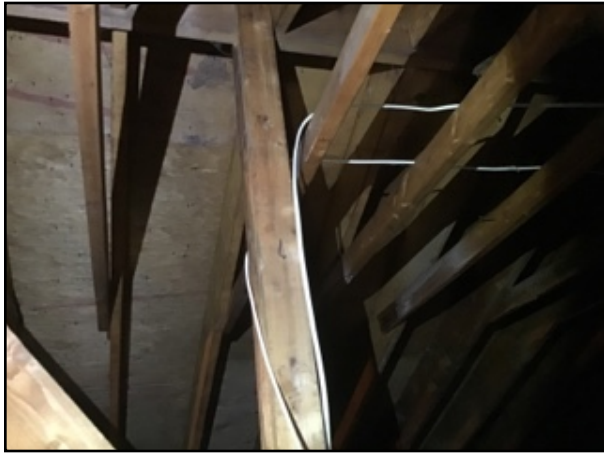
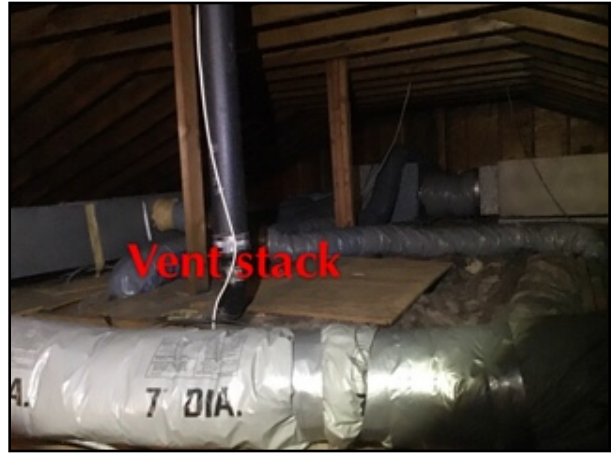
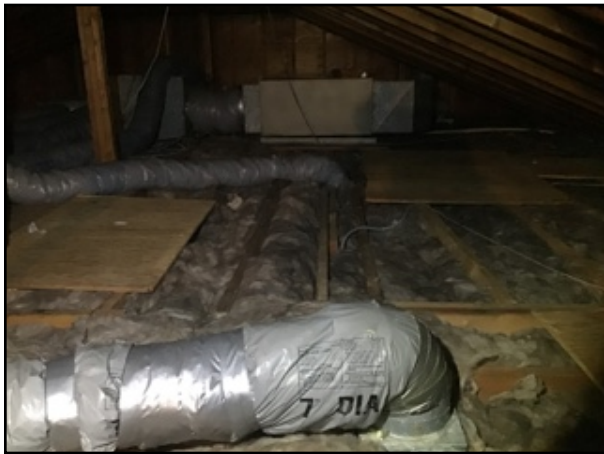
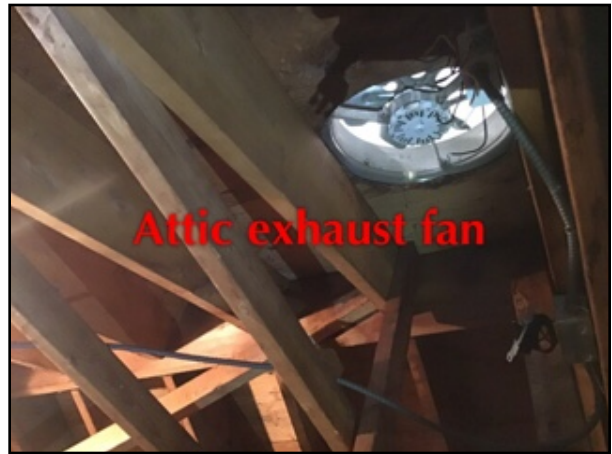
**Comment 22:**
The attic was in good condition with no leaks or signs of moisture or mold. The attic was fully insulated and appeared to be properly ventilated.

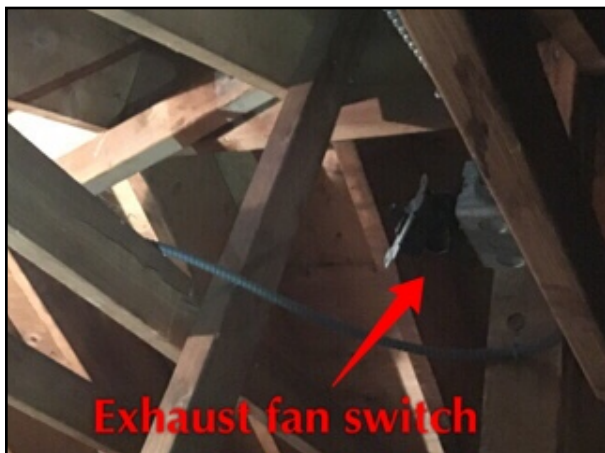
Figure 23-1

Attic exhaust vent switch not properly installed. Recommend hiring a licensed electrical contractor to repair.

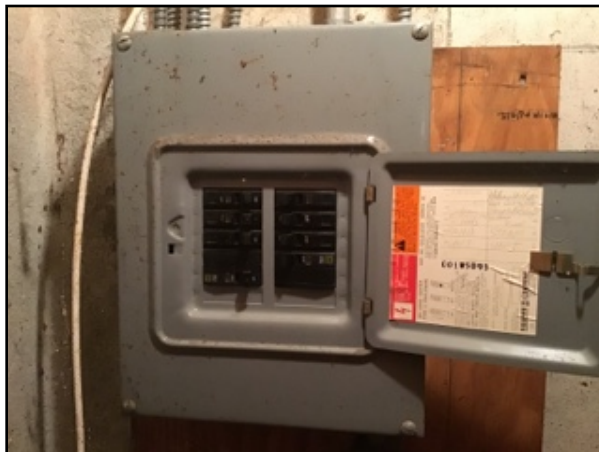
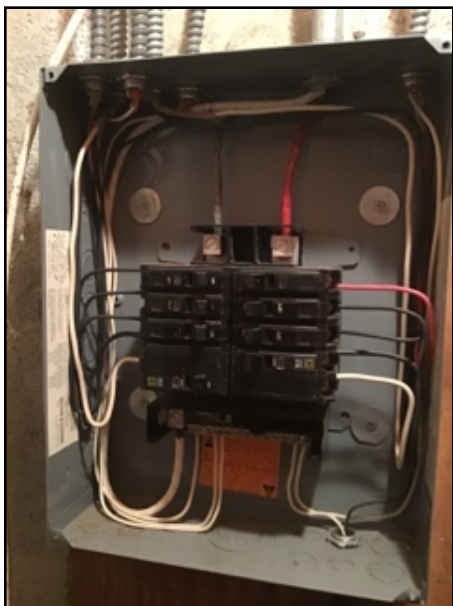
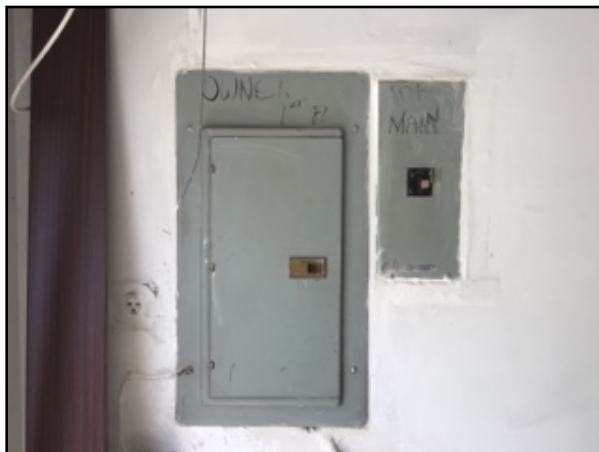
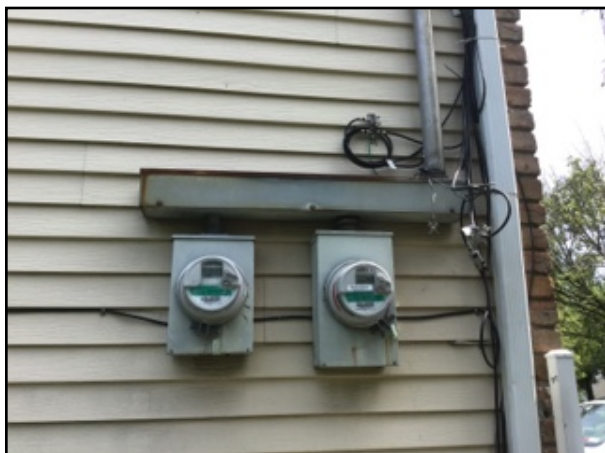
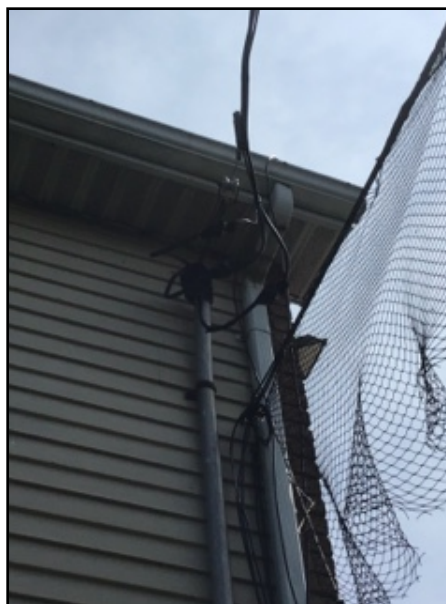
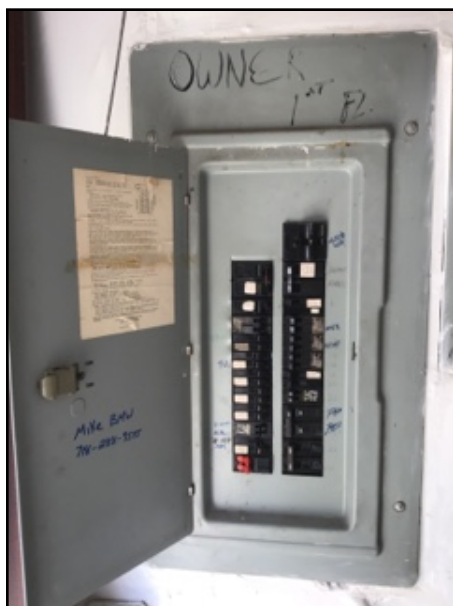
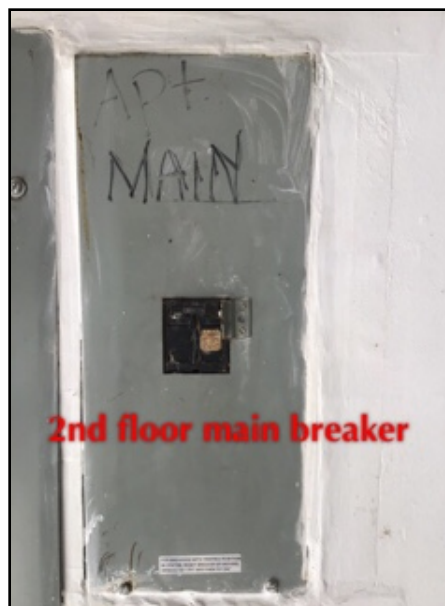
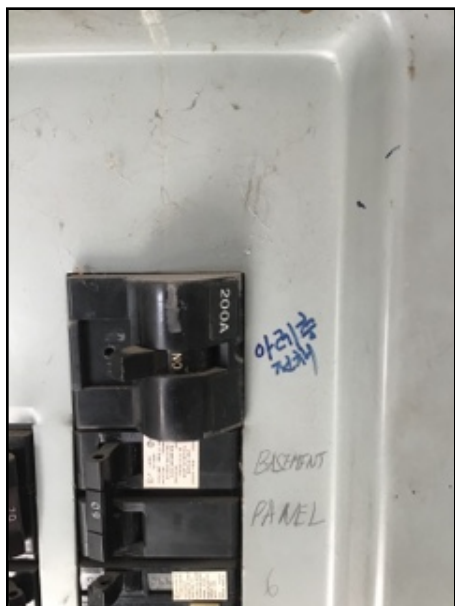
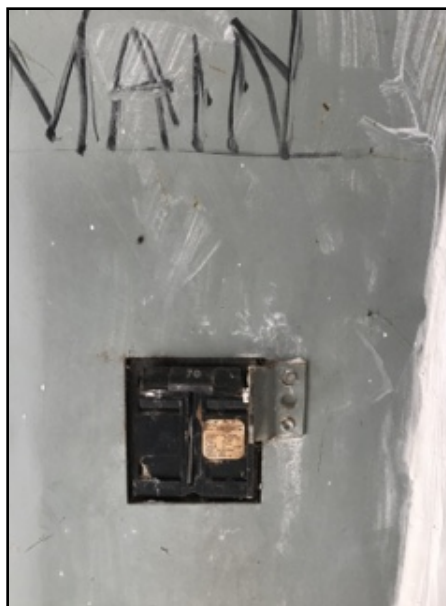
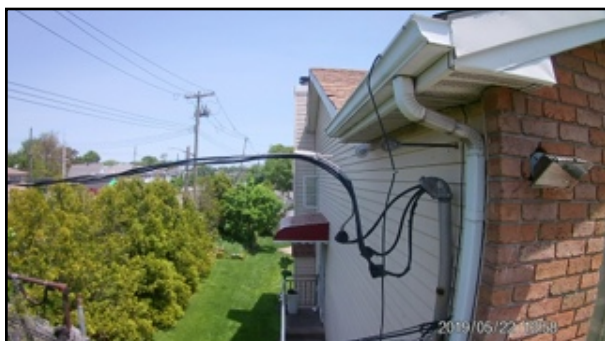
The electrical service is overhead and to a meter on the side of the house. The electric panel was located in the garage and is 200 amp main service. The panel was in marginal condition with no defects noted and grounding was not visible . There was no room for additional expansion. On day of inspection we could not remove panel covers to further evaluate due to them being sealed by plaster.

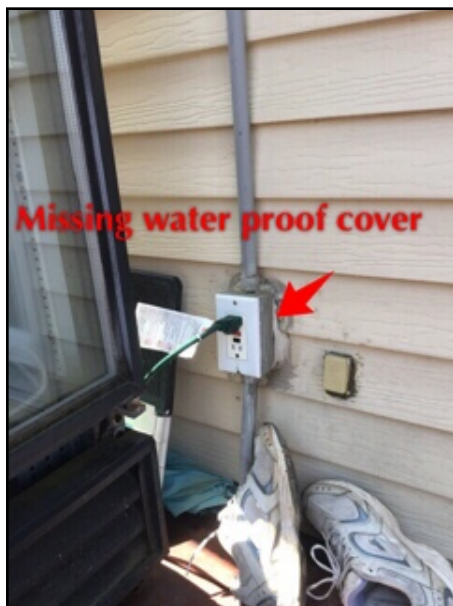
Figure 26-1

All outlets on the exterior of the house and garage should be GFCI outlets for safety purposes. Recommend hiring a licensed electrician to test and replace all exterior and garage outlets with GFCI outlets and install proper covers on the exterior ones if necessary.

Recommend replacing outlet with GFCI. Recommend hiring a licensed electrical contractor to replace.

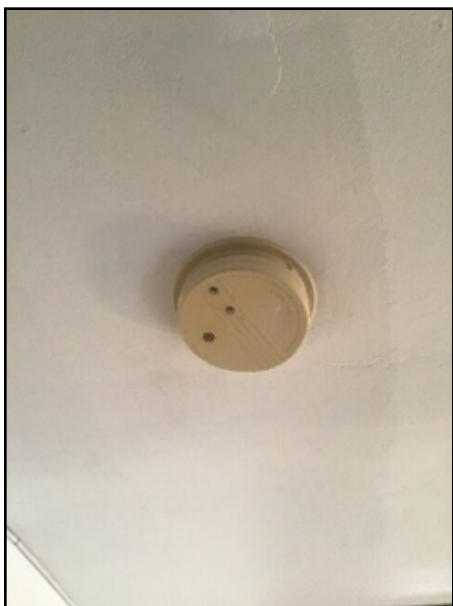
Figure 28-1

Smoke and carbon monoxide detectors are important safety devices designed to save lives. It is always recommended to install new detectors when moving into a home if they are 9 volt battery operated (not hard wired systems).

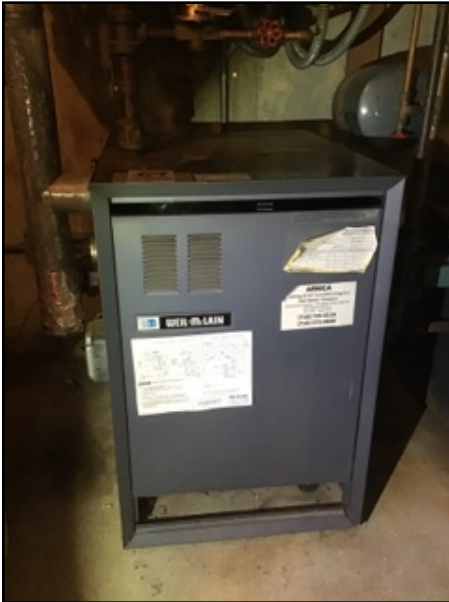
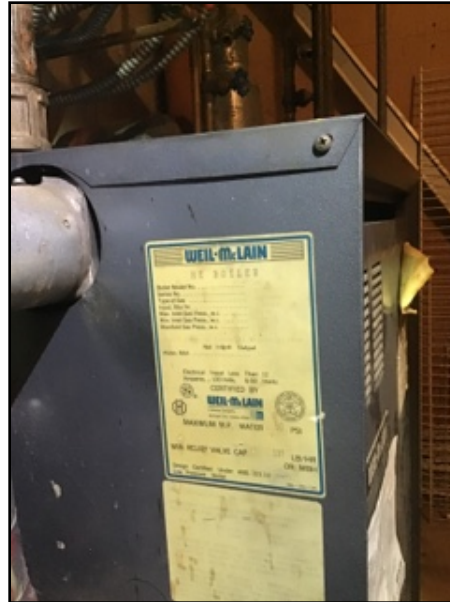
The boiler is a Weil-McClain oil fired unit and in working condition. The unit appears to have been well maintained and serviced properly throughout the years as evidenced by the service tags. The system was tested on the day of inspection and fired properly as heat was delivered to all areas in the house. It is recommended to get annual servicing of the unit to keep it at peak operating efficiency.

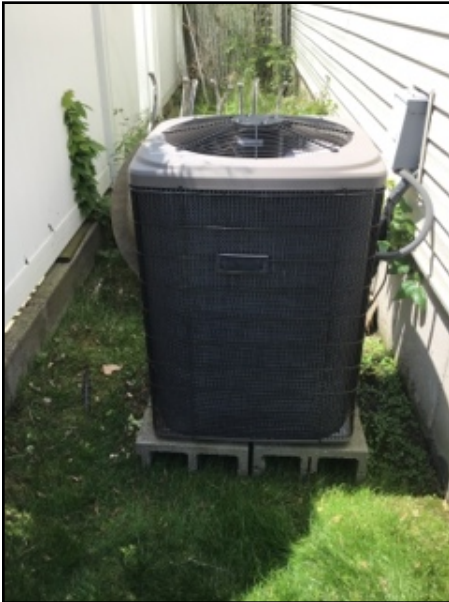
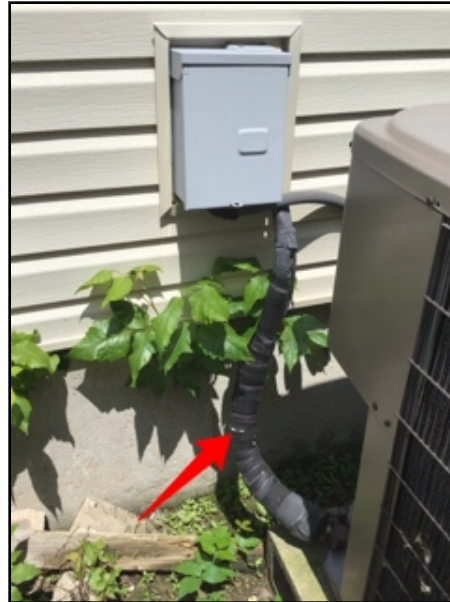
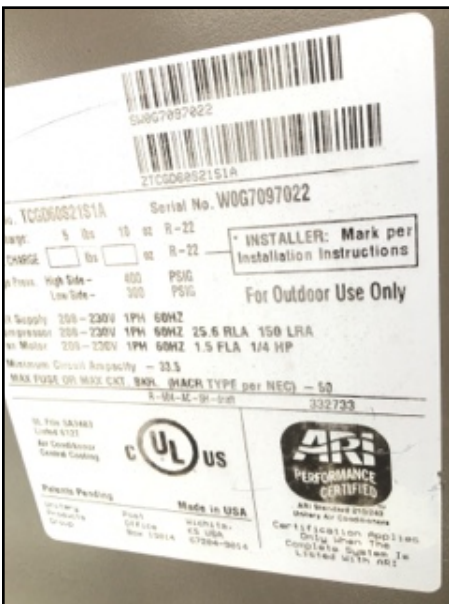
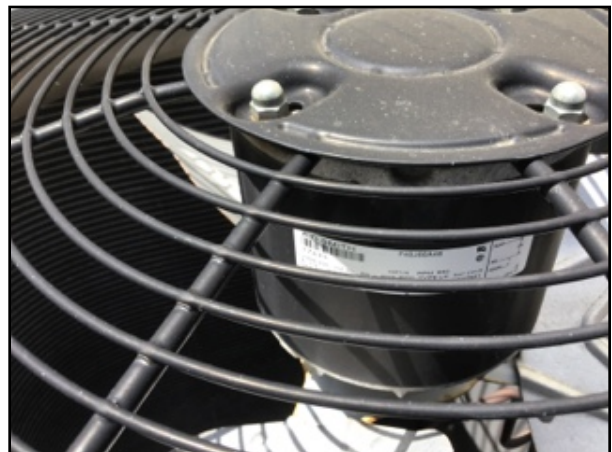
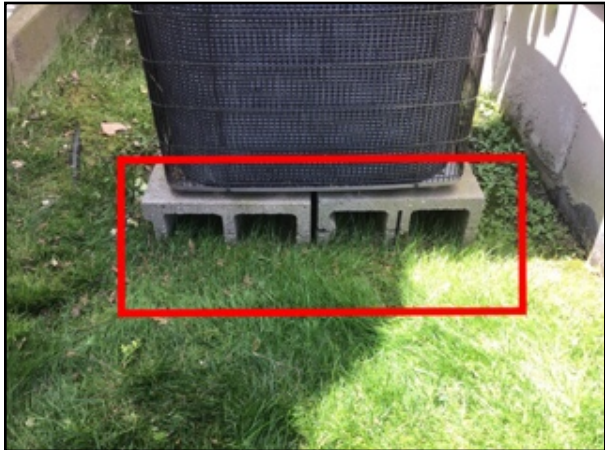
The exterior compressor unit is showing signs of age and is rusted. The refrigerant line installation is worn and frayed and should be replaced. The cinderblocks need to be replaced with a concrete pad. Recommend having a licensed HVAC company come check the exterior condenser unit and replace insulation on the refrigerant line. Unit was not working on day of inspection.

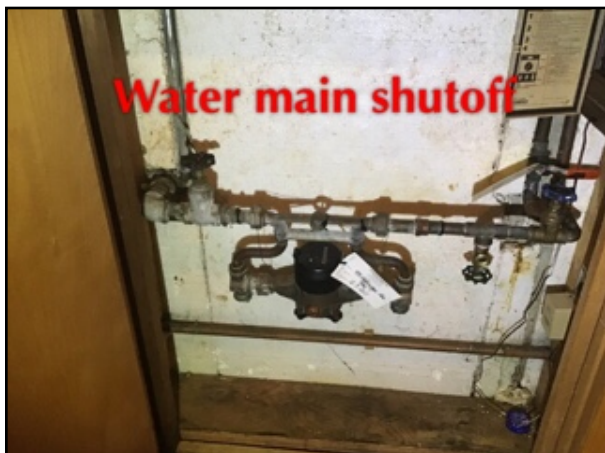
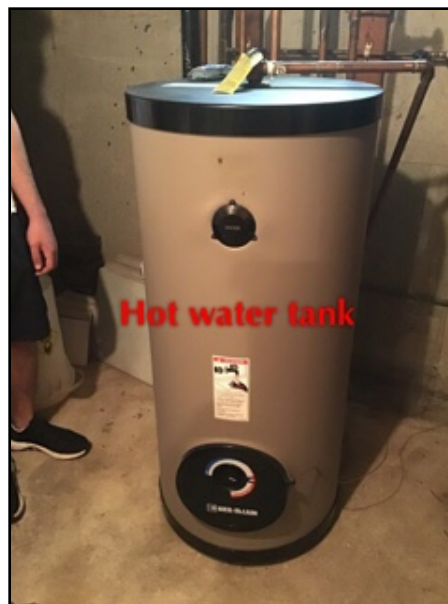
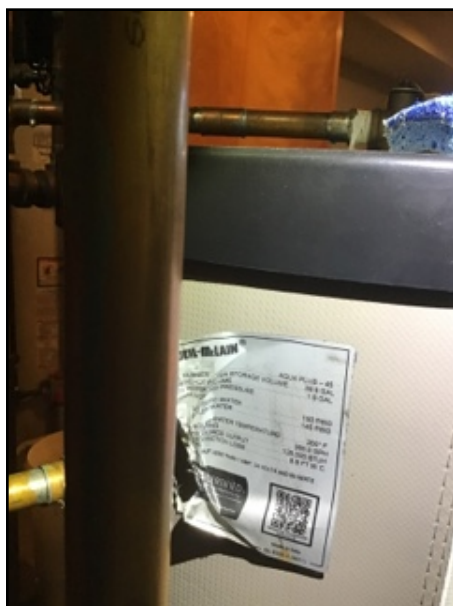
Comment 31:
The plumbing system in the house consists of public water and sewer systems. The water was run through all fixtures for 30 minutes and there were no leaks noted on the supply or drain sides, and no major defects were noted. The main sewer pipe was cast iron and all the visible supply lines are copper pipe. Numerous drain and water lines were not visible due to the basement being finished but no leaks were noticed at or on the basement ceiling.

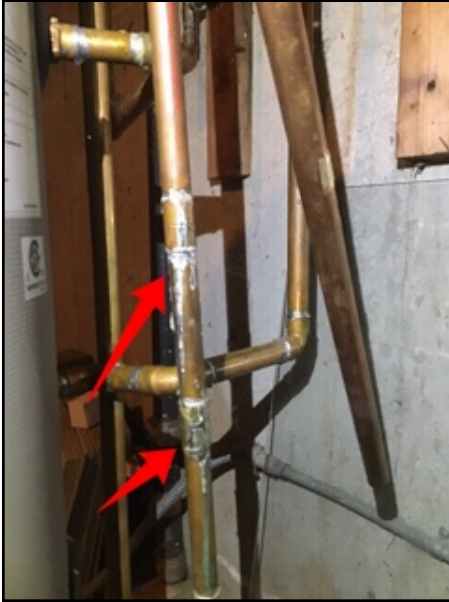
Figure 32-1

On day of inspection signs of corrosion are visible on the supply lines of the hot water tank. Recommend hiring a licensed plumber to further evaluate.

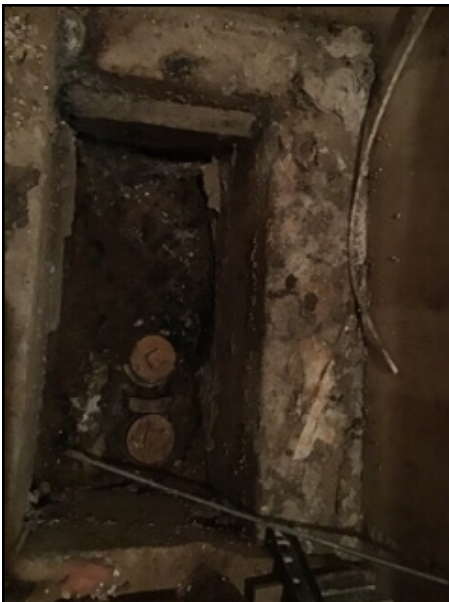
Figure 33-1

The enclosure of the p-trap in the basement shows signs of a mold like substance. Recommend hiring a licensed mold contractor to evaluate.

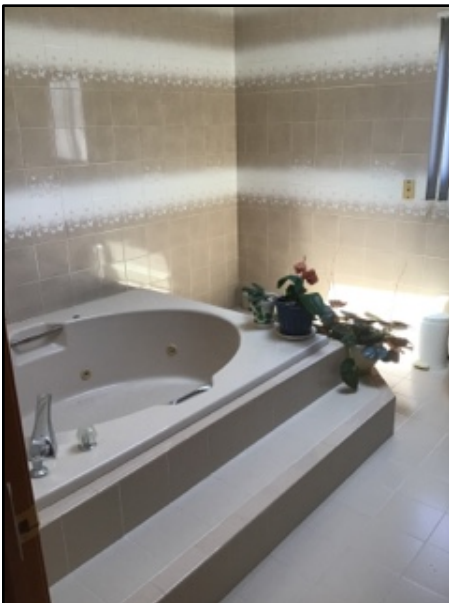
Figure 34-1

The main bath was in working condition with no leaks noted at the sink, toilet or tub/shower. The GFCI outlet was tested and operated properly on the date of inspection. There was a window and exhaust fan for ventilation and no mold or mildew was noted on the walls or ceiling.

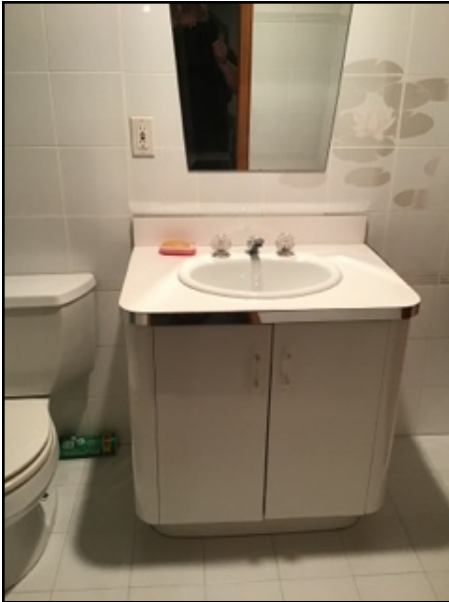
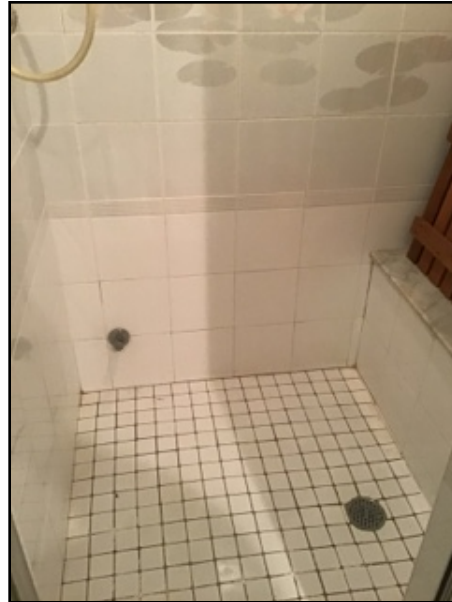
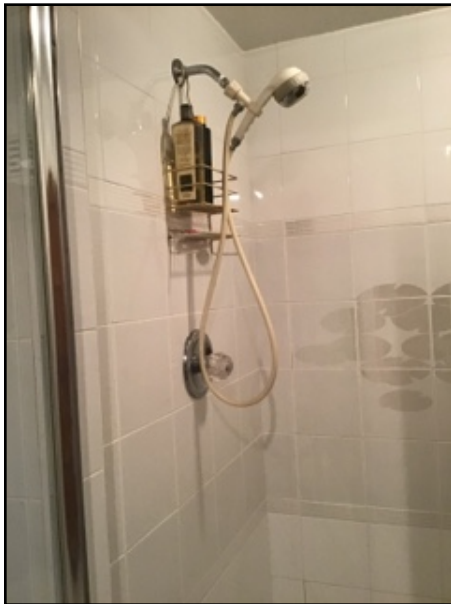
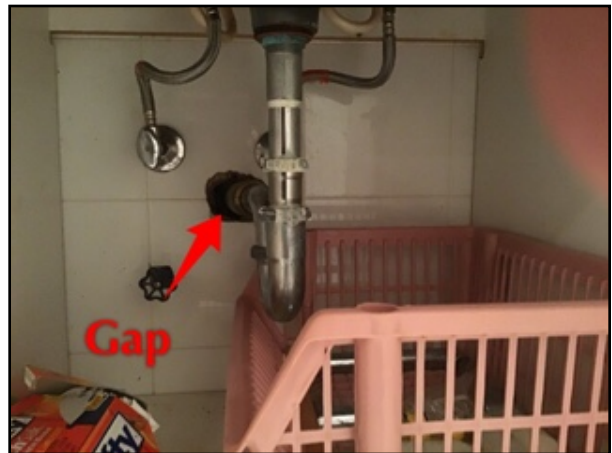
The basement bathroom was in working condition with no leaks noted at the sink, toilet or tub/shower. The GFCI outlet was tested and operated properly on the date of inspection. There was a exhaust fan for ventilation and no mold or mildew was noted on the walls or ceiling. Sink is backed up defect noted.

Basement bathroom sink is clogged. Recommend hiring a licensed plumber to repair.

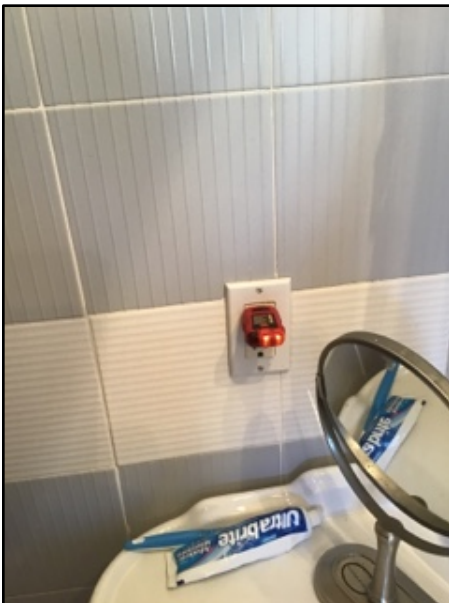
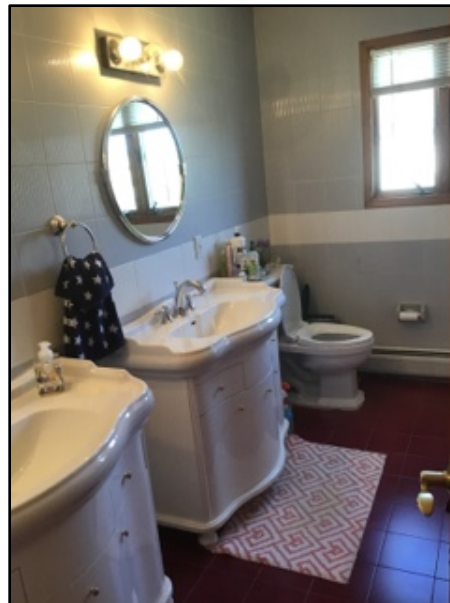
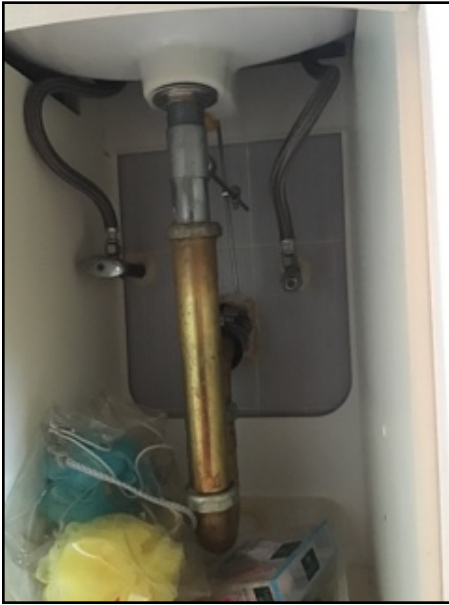
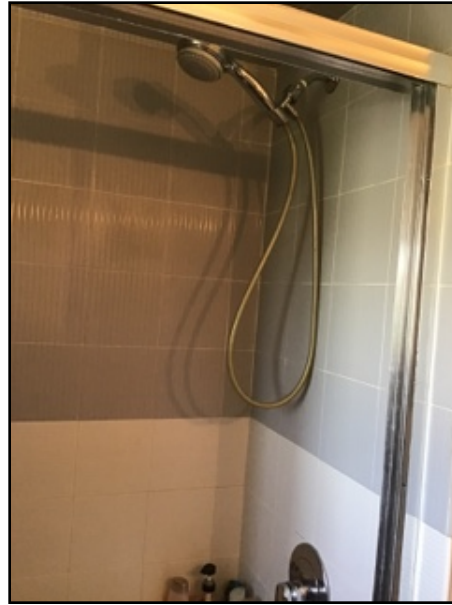
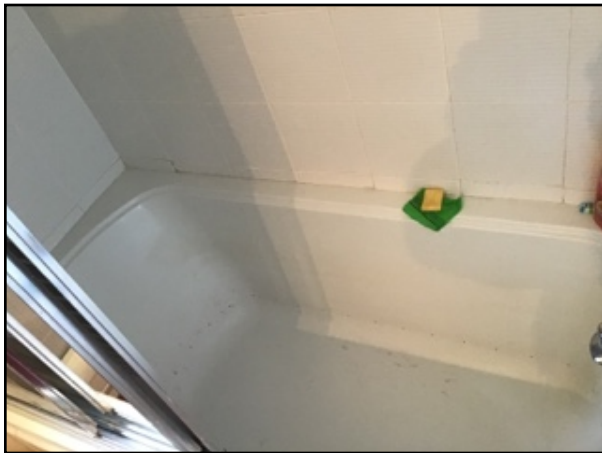
The 2nd floor bathroom was in working condition with no leaks noted at the sink, toilet or tub/shower. The GFCI outlet was tested and operated properly on the date of inspection. There was a window and exhaust fan for ventilation and no mold or mildew was noted on the walls or ceiling.

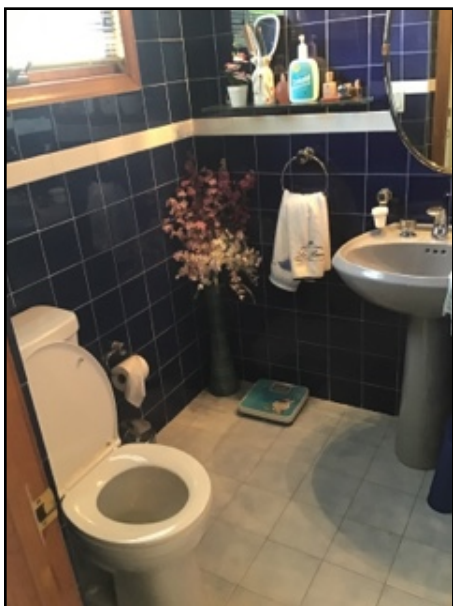
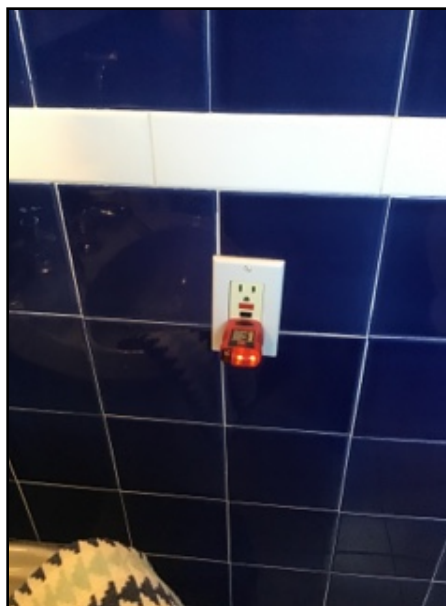
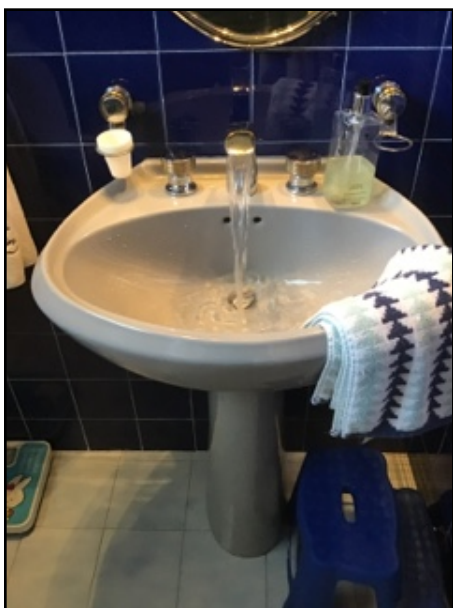
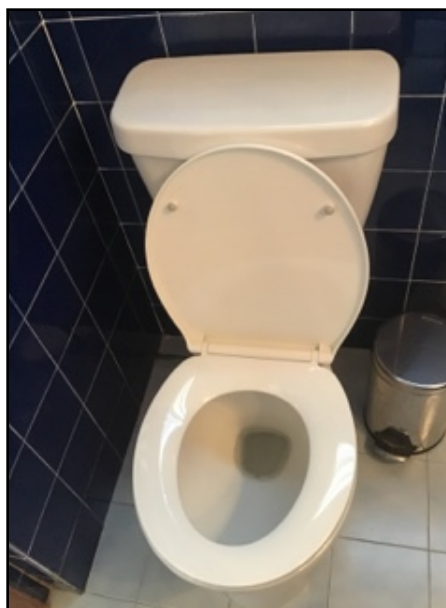
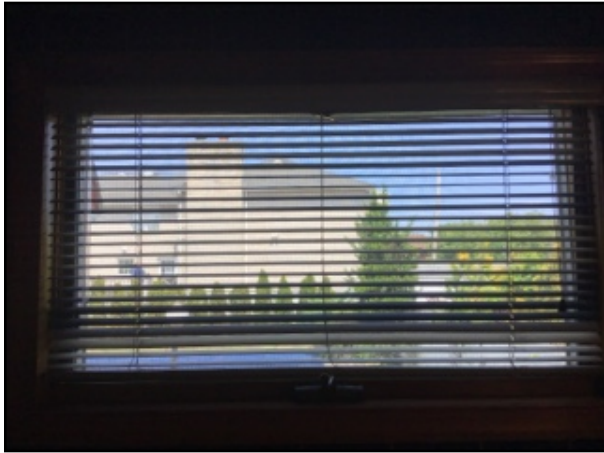
The 1st floor main bath was in working condition with no leaks noted at the sink, toilet or tub/shower. The GFCI outlet was tested and operated properly on the date of inspection. There was a window for ventilation and no mold or mildew was noted on the walls or ceiling.

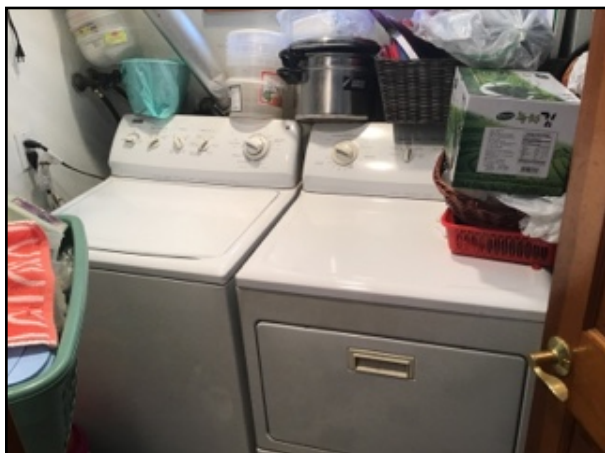
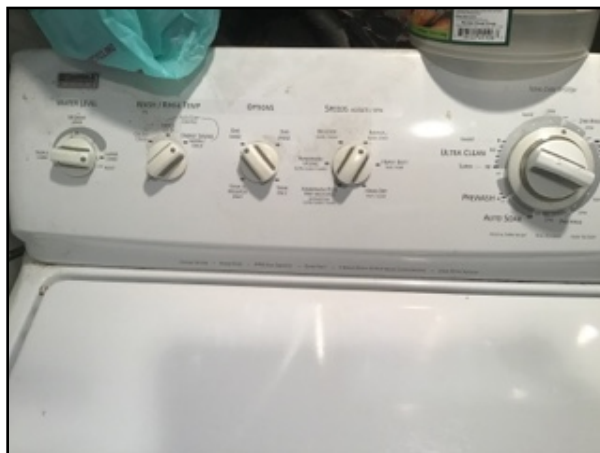
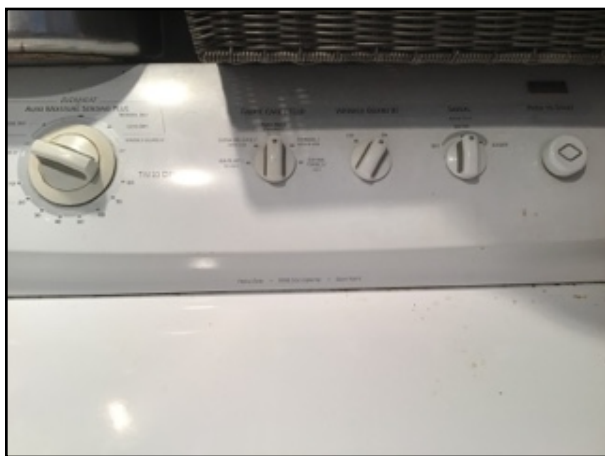
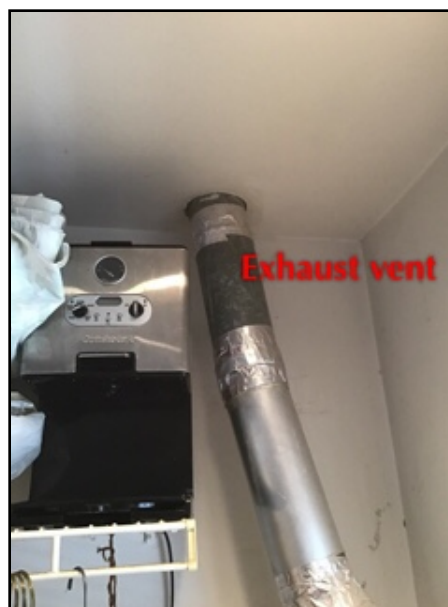
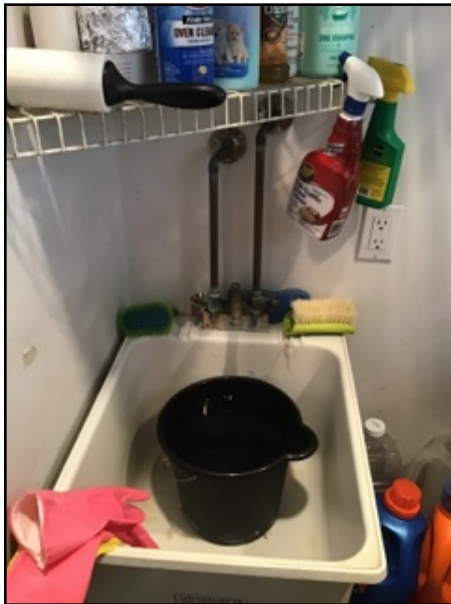
The laundry area was in acceptable condition with defects noted. There were no leaks at the washing machine connections and there was an exhaust hose present to vent the dryer to the exterior.

The outlet in the laundry area was not a GFCI outlet and is a safety hazard as it is directly below/next to the water supply lines. Recommend hiring a licensed electrician to replace the existing outlet with a GFCI outlet as necessary.
