Ground Up Home Inspections

Inspected By: Manny Theocharidis. Lic # 16000098512

Property Inspection Report

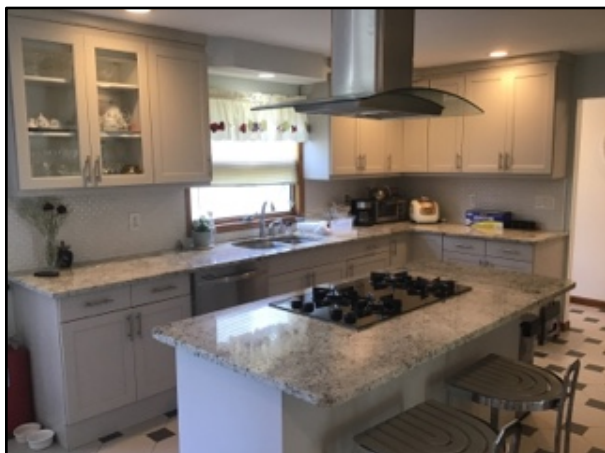
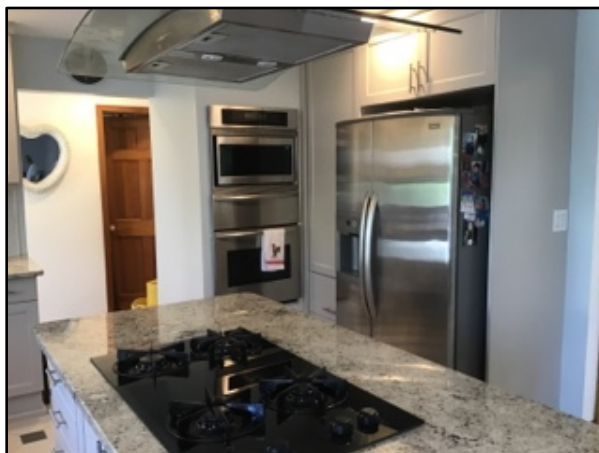
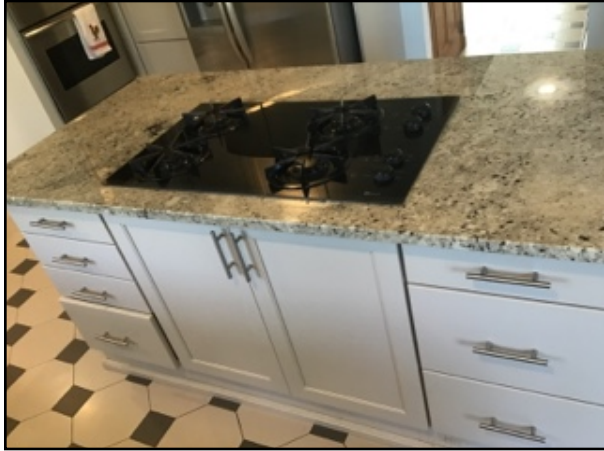
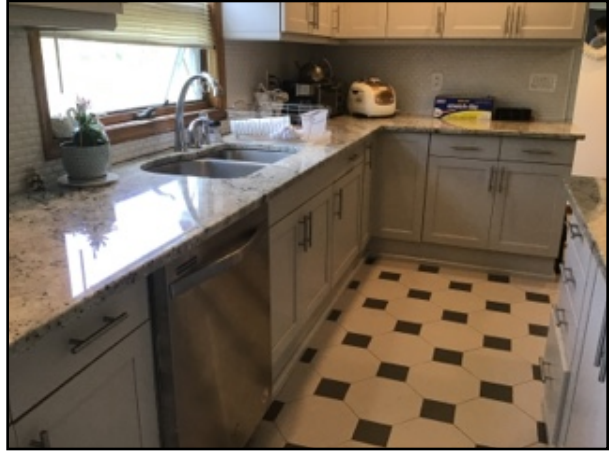
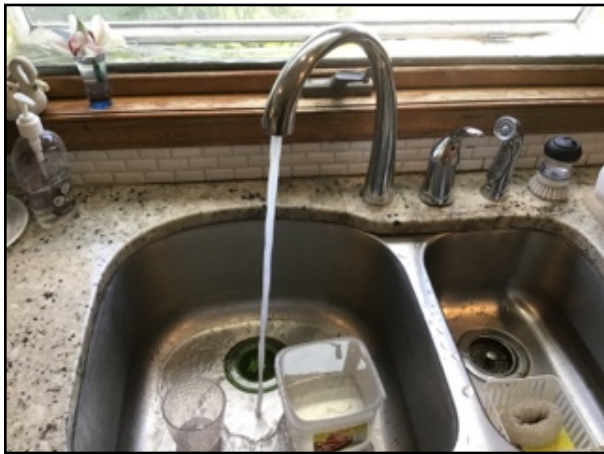
The kitchen was in working condition with defects noted. There were no leaks at the sink or dishwasher, and all the appliances were tested and operated properly on the date of inspection. All the cabinets and countertops were operational and secure. The exhaust fan over the stove (range hood exhaust) were tested and operated properly on the date of inspection.

The outlets in the kitchen sink area are not GFCI protected and this is a safety hazard. Recommend hiring a licensed electrician to replace all outlets within 6' of the sink with GFCI outlets. Recommend replacement of flex pipe with aluminum p-trap pipe. Recommend hiring a licensed plumber for further evaluation.

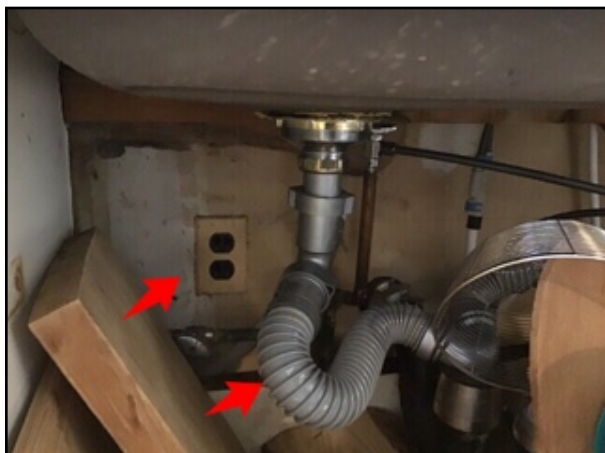
Figure 42-1

The outlets in the kitchen counter top area are not GFCI protected and this is a safety hazard. Recommend hiring a licensed electrician to replace all outlets within 6' of the sink with GFCI outlets.

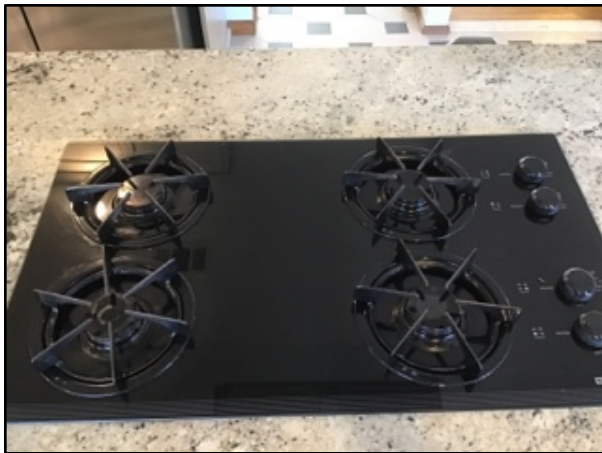
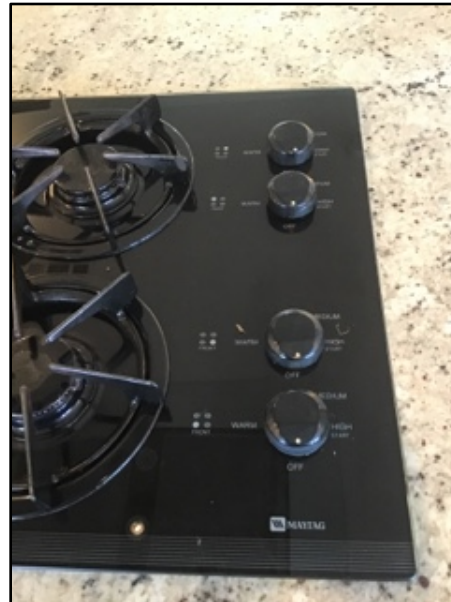
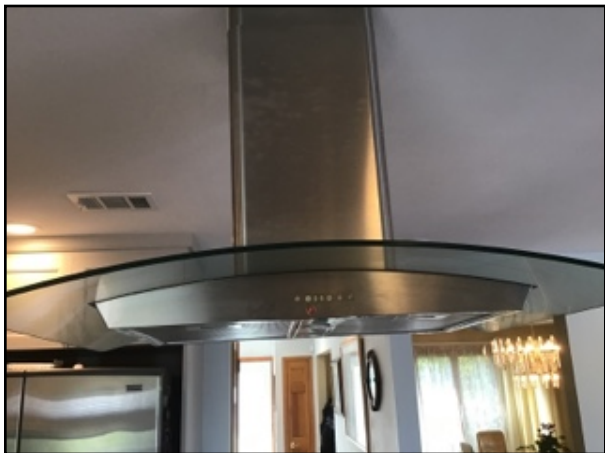
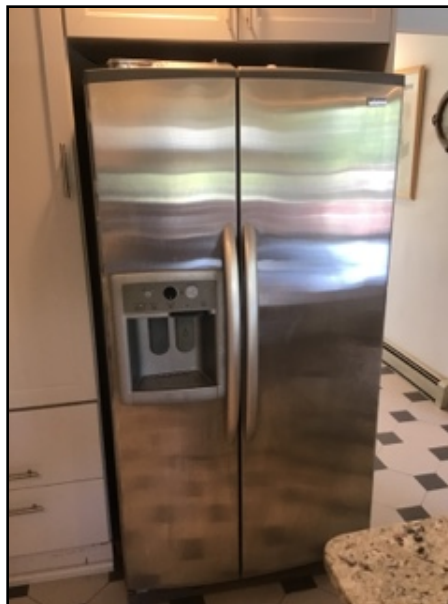
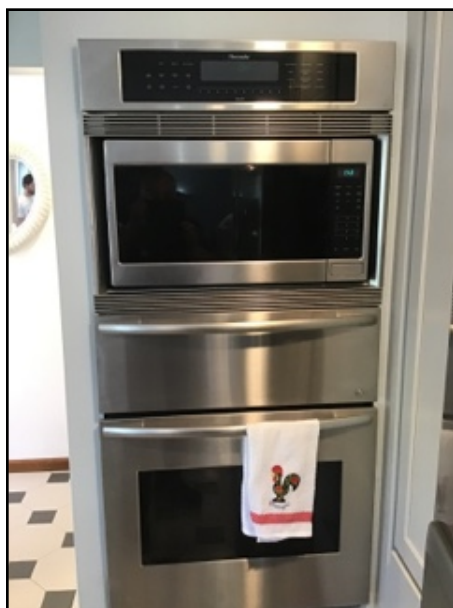
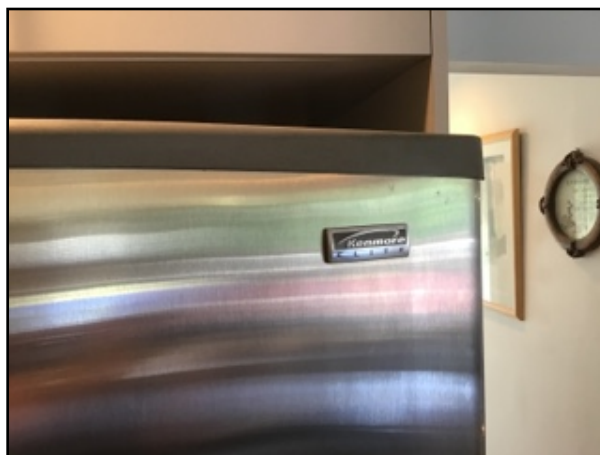
All the appliances were tested and were in working condition. The cook top was vented by a range hood exhaust and operated properly. The sink is a single unit in good condition with no leaks noted.

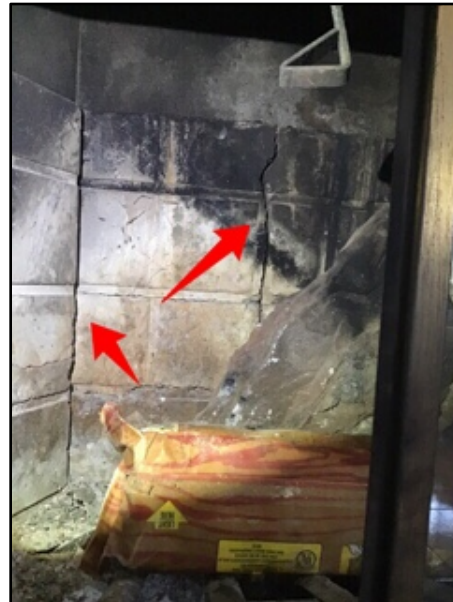
Figure 45-2

The fireplace is in poor condition with cracks and missing mortar in the fire box. It is ALWAYS recommended to have the flue inspected and cleaned prior to use. Recommend hiring a qualified mason or chimney contractor to assess and repair as necessary.

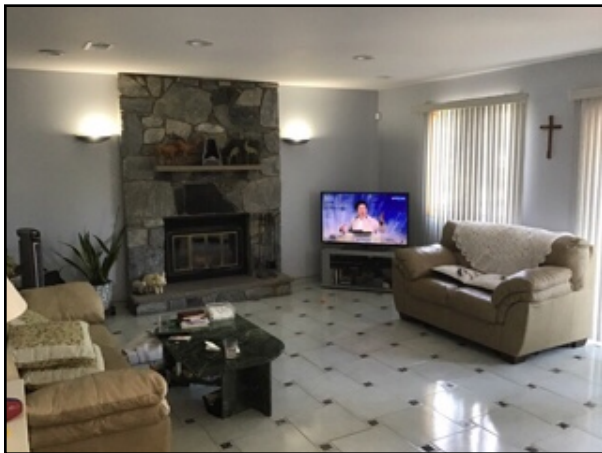
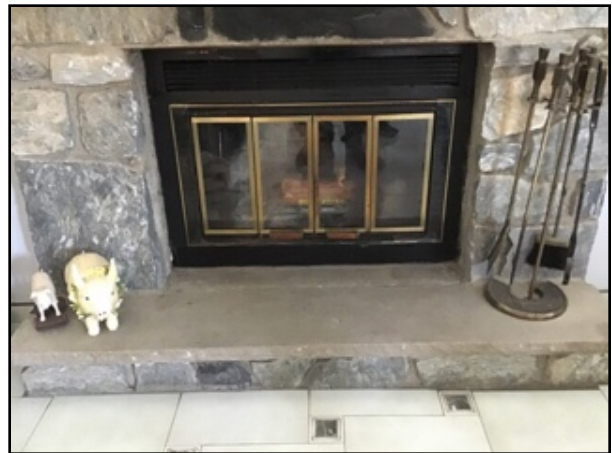
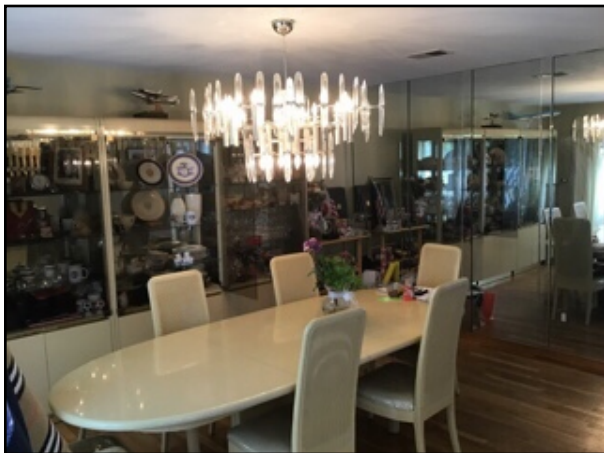
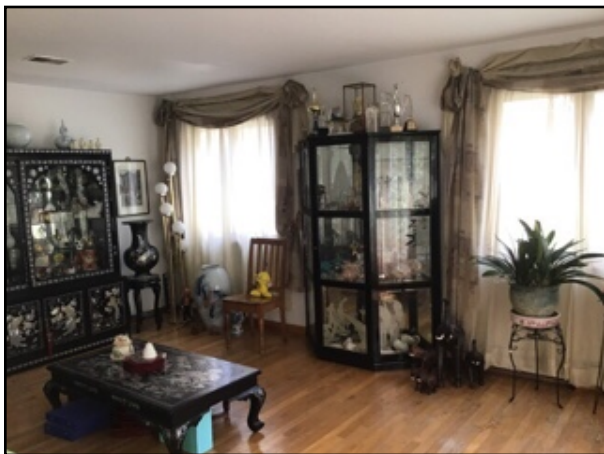
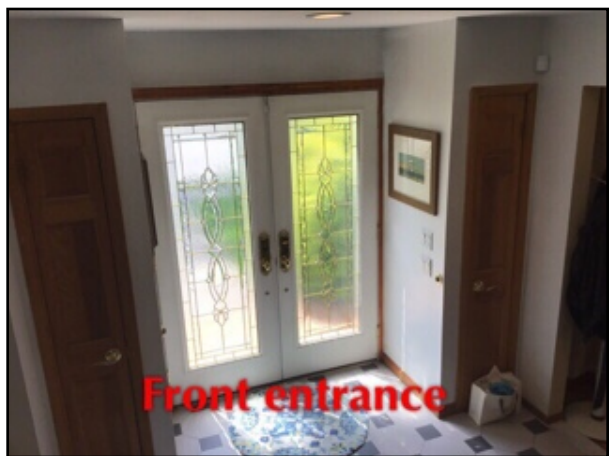
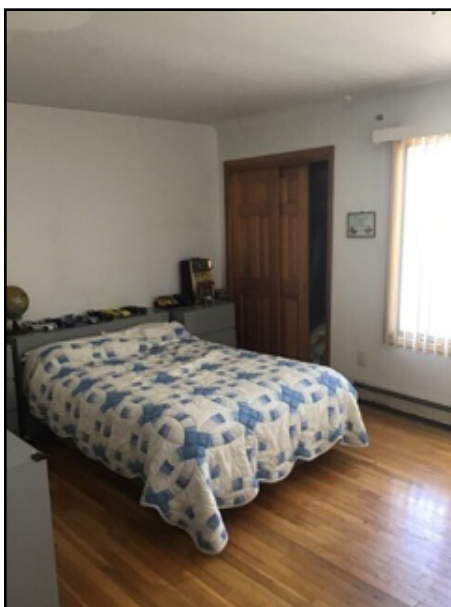
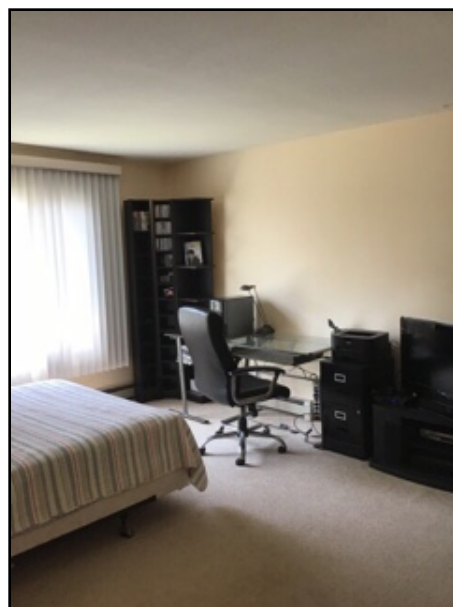
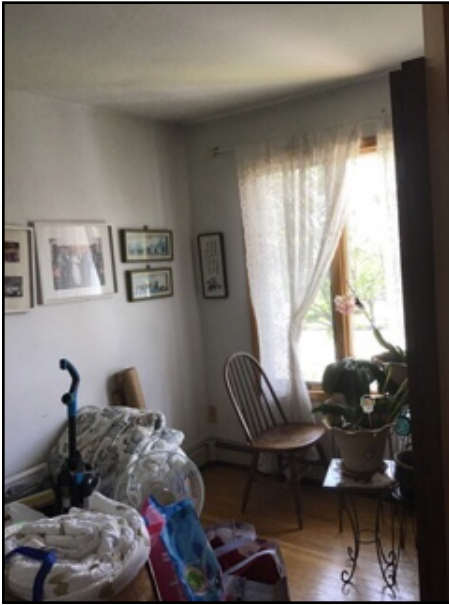
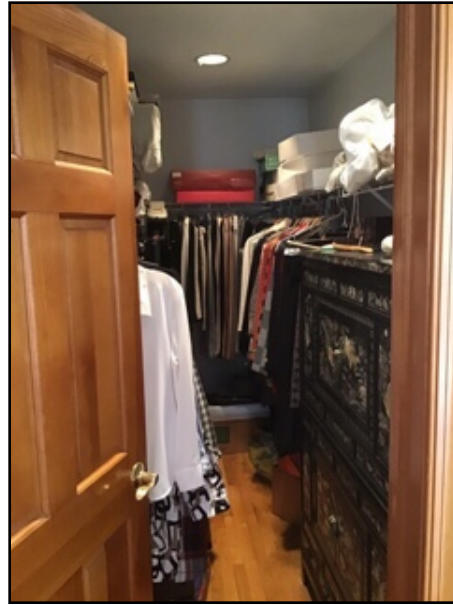
The interior was in overall good condition with no major defects noted. All floor surfaces were in marginal condition and the majority of the electrical outlets were three-pronged and grounded properly. There were no major cracks or holes in the walls or ceilings, and the floors were level with minimal bounce. Windows were tested randomly and operated properly.

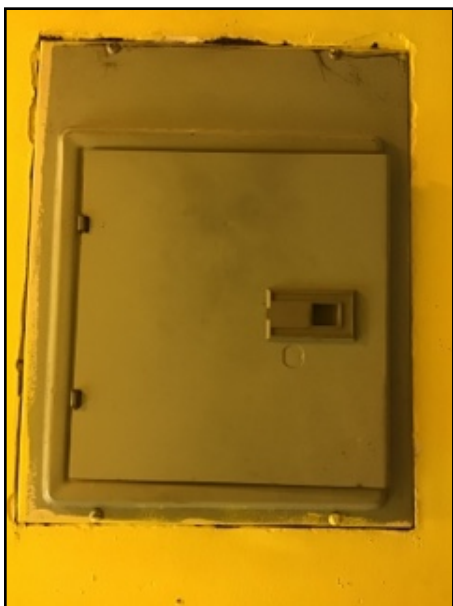
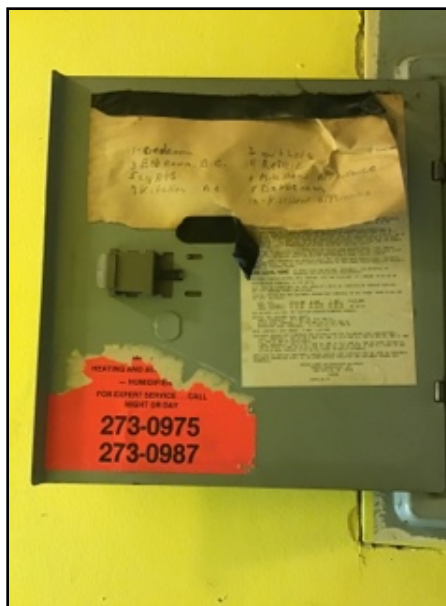
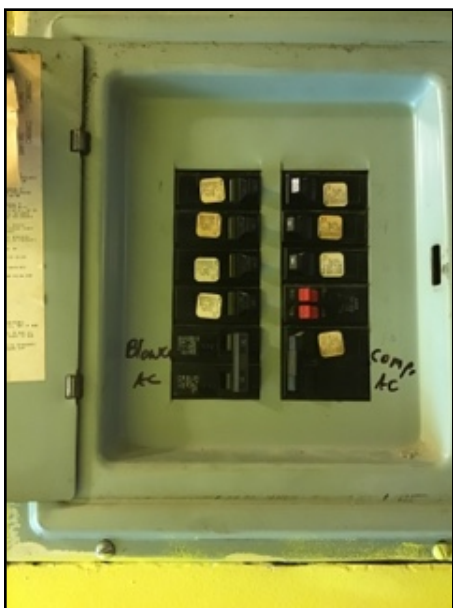
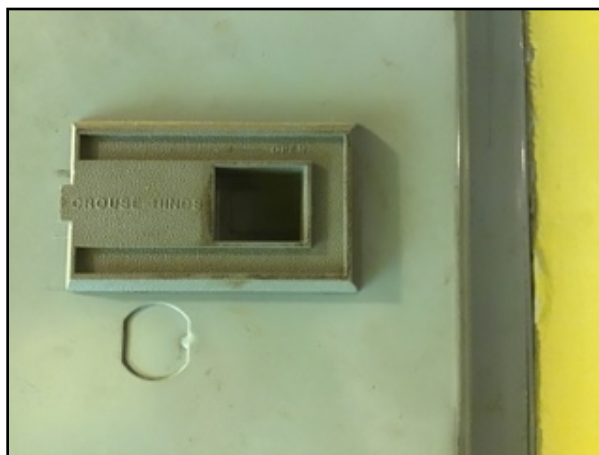
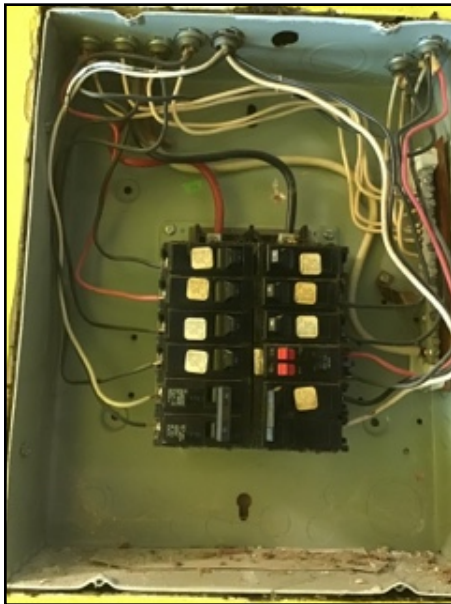
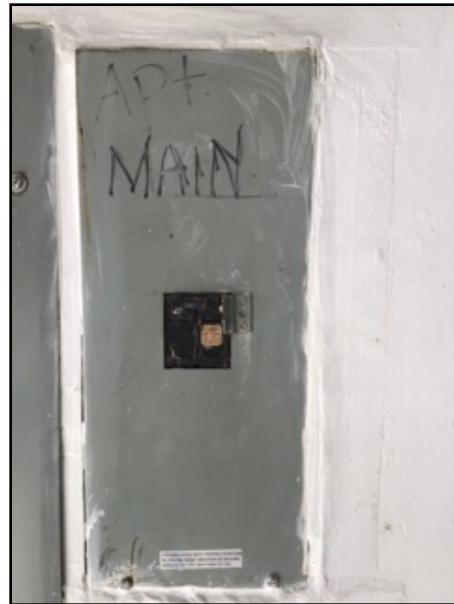
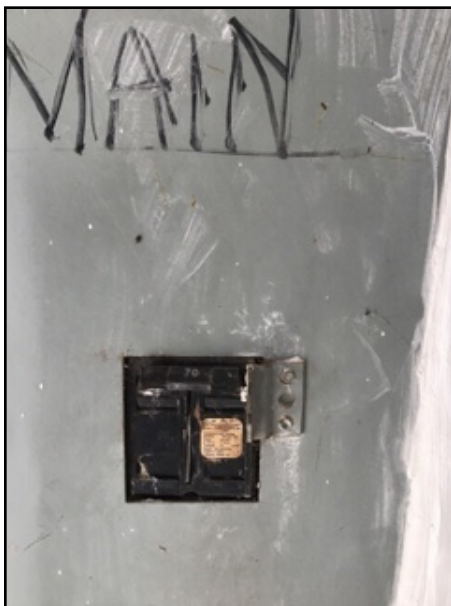
Comment 49:
Unit #2's electrical service is overhead and to a meter and panel in the garage which is a 70 amp main service. The panel was in good condition with no defects noted and grounding was proper. There were no double taps or missing covers and there was no additional room for expansion.

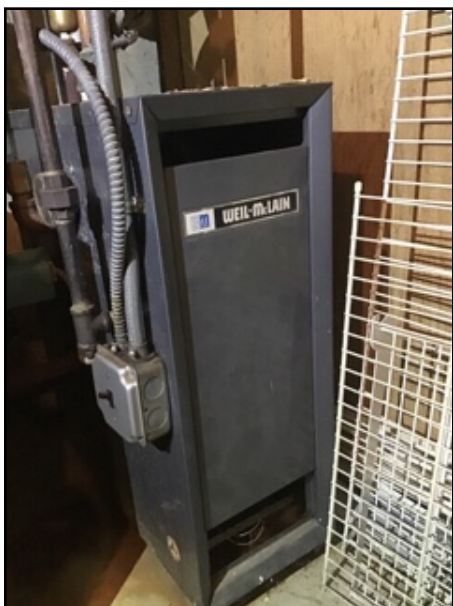
Figure 51-1

The boiler is a Weil-McClain oil fired unit and approximately years old and in working condition. The unit appears to have been well maintained and serviced properly throughout the years as evidenced by the service tags. The system was tested on the day of inspection and fired properly as heat was delivered to all areas in the apartment . It is recommended to get annual servicing of the unit to keep it at peak operating efficiency.

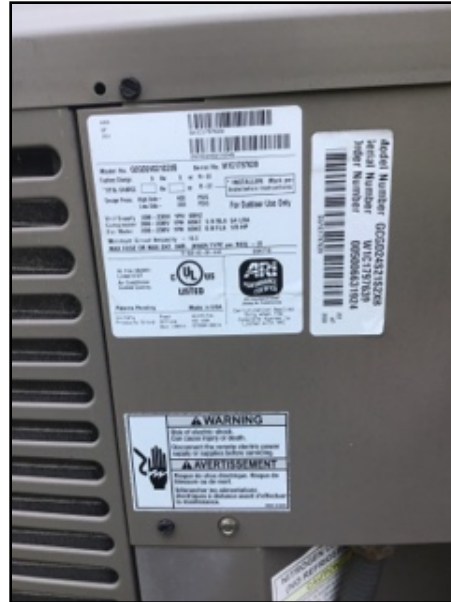
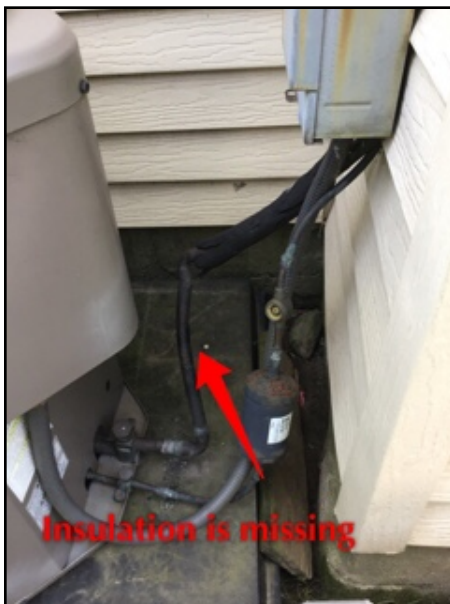
The air conditioning system was tested and did not operate properly on the date of inspection. Discharge temperature was higher than the thermostat set point. It is recommended to have proper servicing done annually to ensure maximum efficiency. The refrigerant lines and electrical disconnects were noted and in marginal condition.

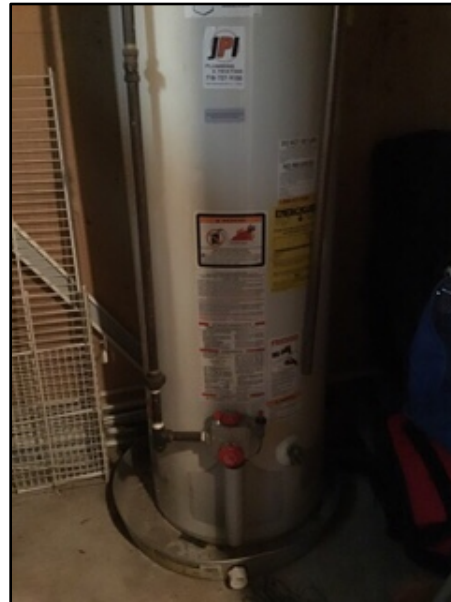
Figure 53-2

The 2nd floor hot water tank is a gas heated tank made by GE and is 15 years old. The unit is past its life expectancy. Recommend hiring a licensed plumber to replace the tank and pipe fittings where corroded.

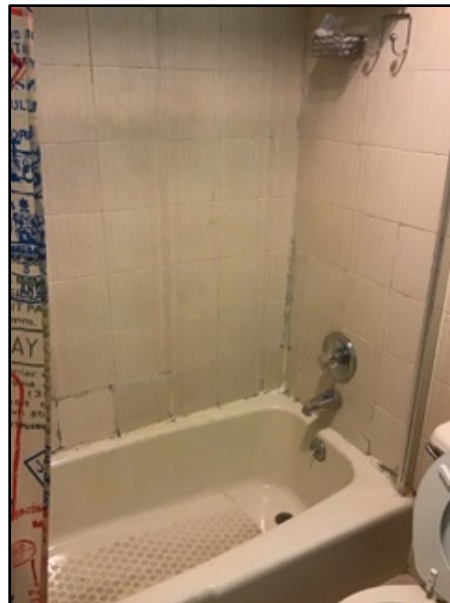
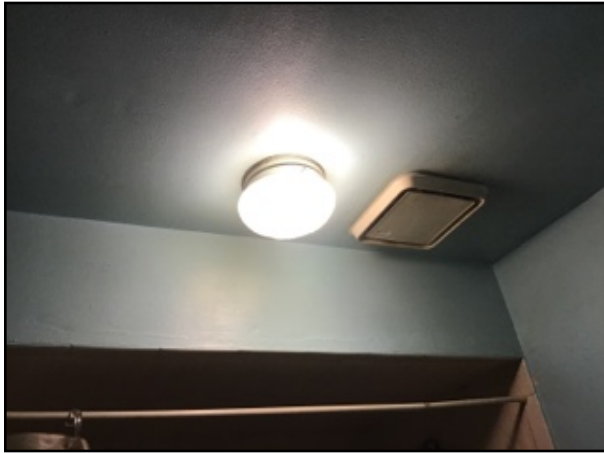
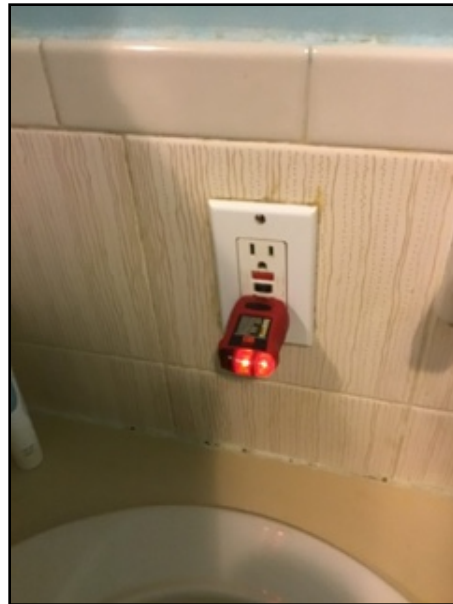
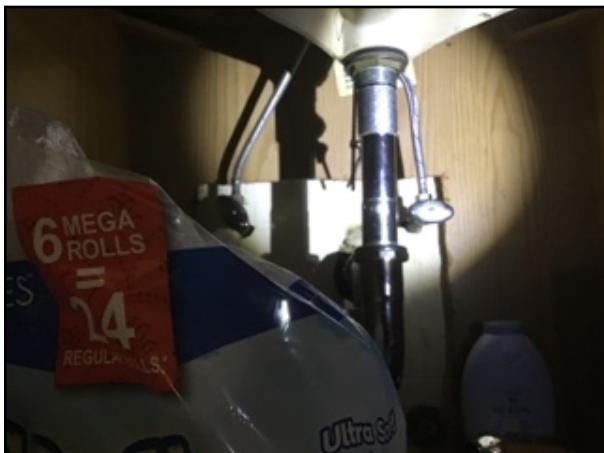
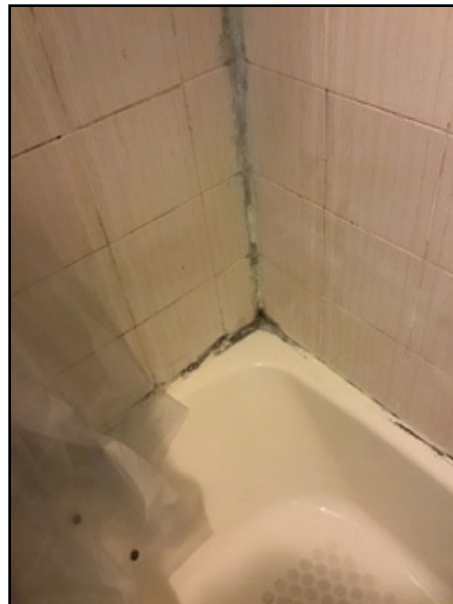
The main bath was in working condition with no leaks noted at the sink, toilet or tub/shower. The GFCI outlet was tested and operated properly on the date of inspection. There was an exhaust fan for ventilation and mildew was noted on the walls in tub area.

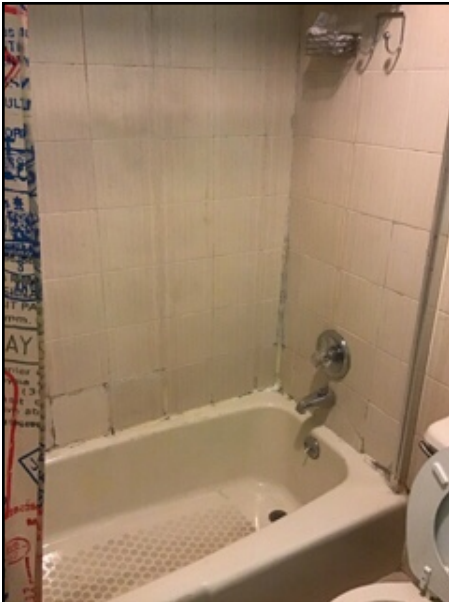
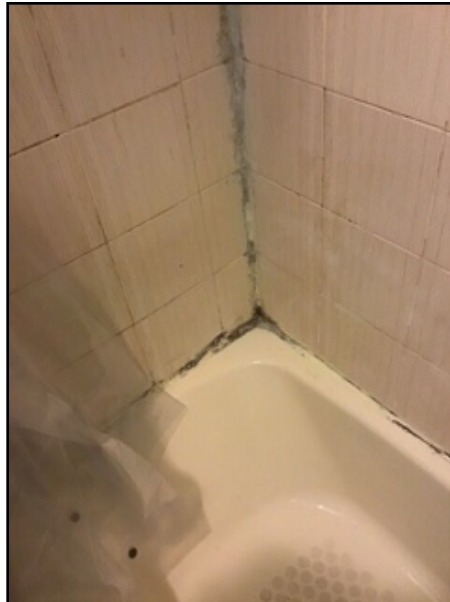
Comment 56:
There is grout missing in the tub/shower. Also cracked tiles were noted. Recommend hiring a qualified contractor to re-grout and replace cracked tiles as necessary to prevent water from getting behind the tiles.

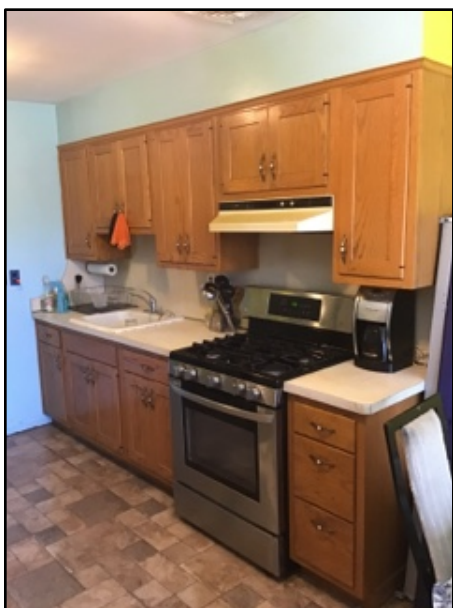
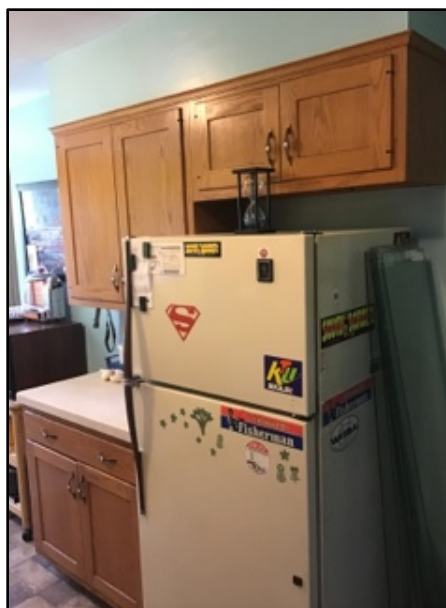
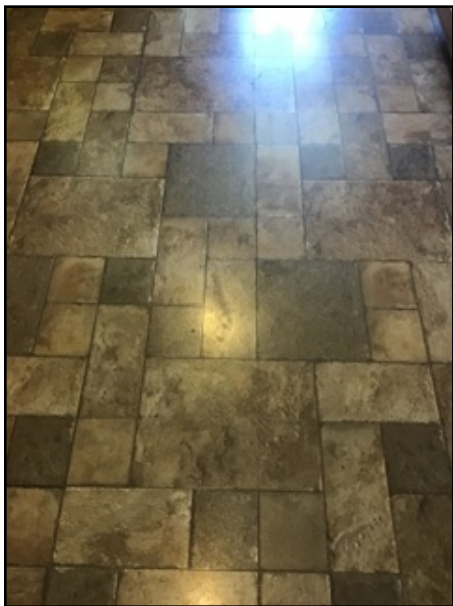
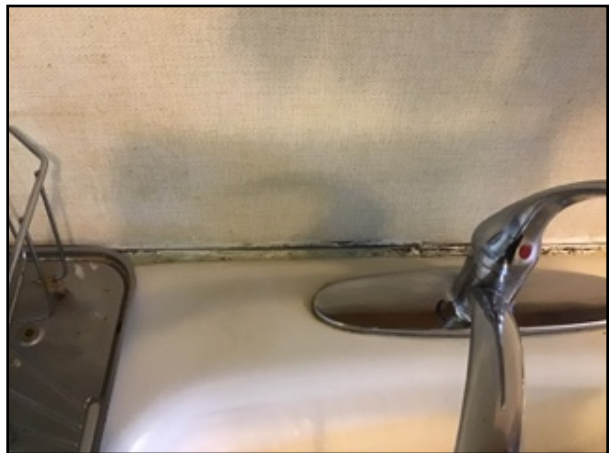
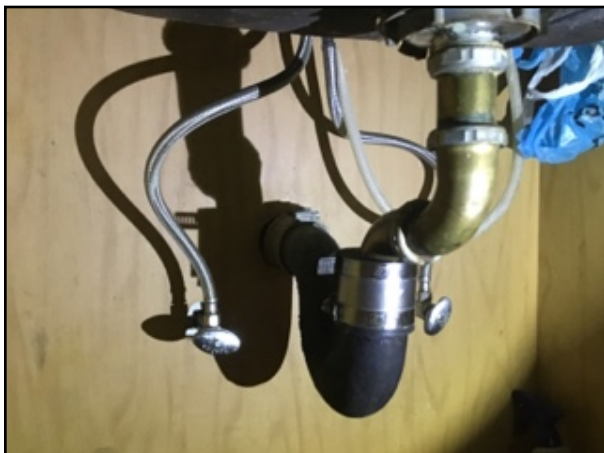
The kitchen in unit 2 was in working condition with defects noted. There were no leaks at the sink and all the appliances were tested and operated properly on the date of inspection. All the cabinets and countertops were operational and secure. The exhaust fan over the stove (range hood exhaust) and there was no GFCI outlet.

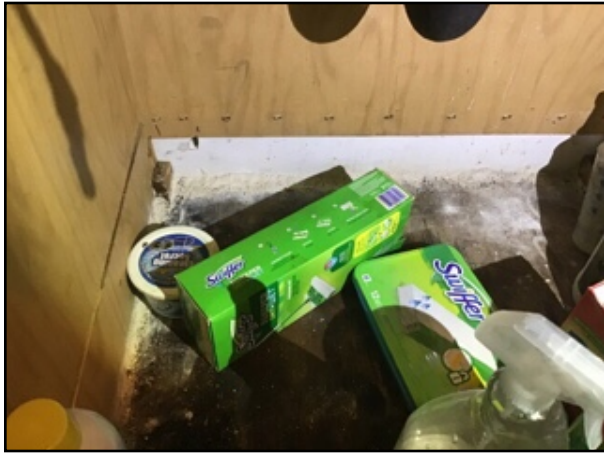
Figure 59-1

On day of inspection noticed possible mold like substance under kitchen sink. Recommend hiring a licensed mold inspector for further evaluation. Also, noticed possible mouse droppings under sink. Recommend hiring a licensed exterminator for further evaluation.

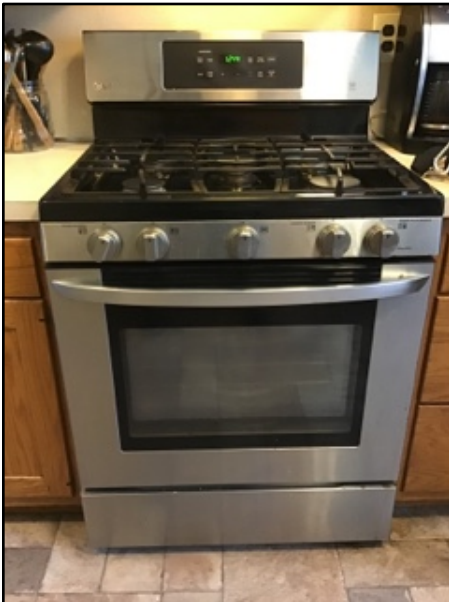
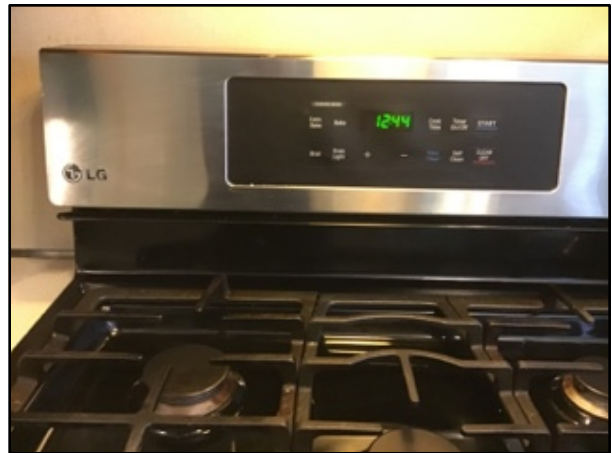
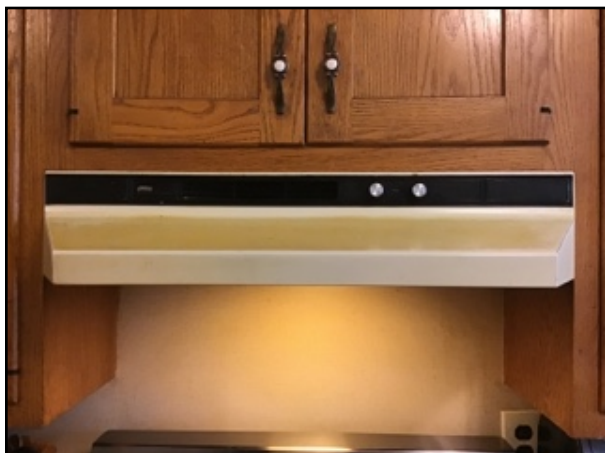
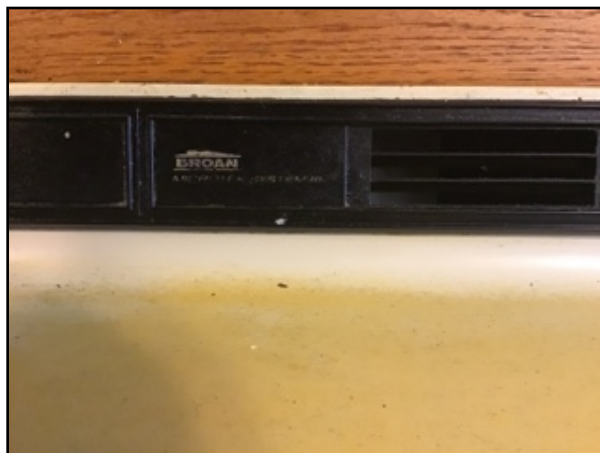
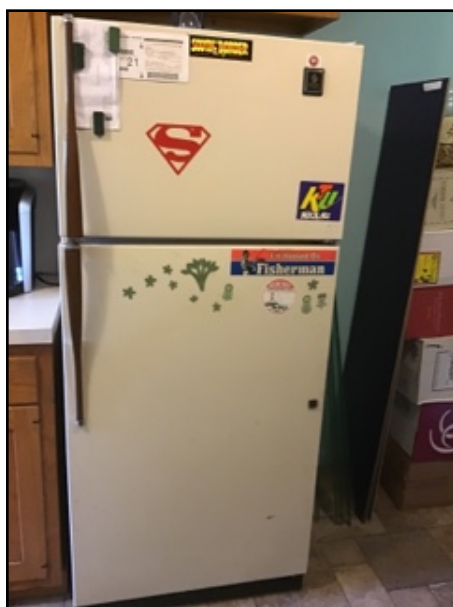
All the appliances were tested and were in working condition. The stove was vented by an exhaust fan and the sink is a single unit in good condition with no leaks noted on the day of inspection.

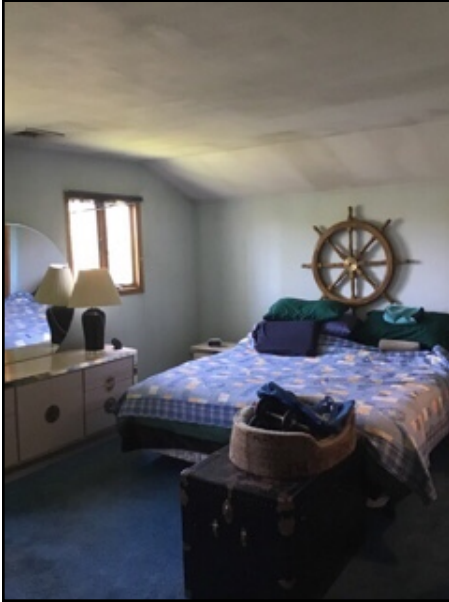
Figure 62-1

Although older and outdated, the interior was in overall good condition with defects noted. All floor surfaces were in good condition and the majority of the electrical outlets were three-pronged and grounded properly. There were cracks noted on the ceilings, and the floors were level with minimal bounce. Windows were tested randomly and did not operate properly.

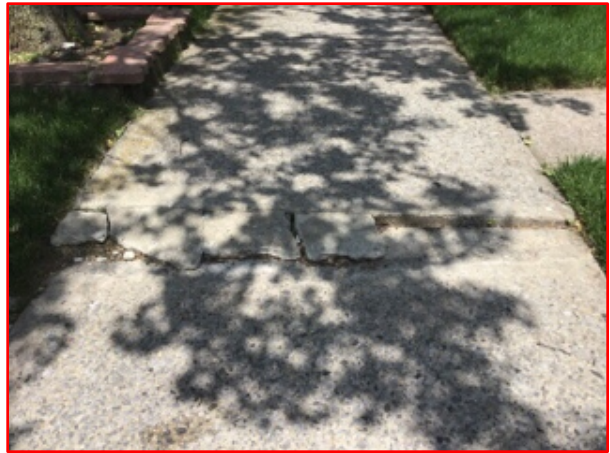
Figure 3-2

1) The front and side concrete walkway is in marginal condition as there are areas of concrete deterioration and cracking. Major tripping hazard. Recommend contacting a qualified mason to assess the situation and repair or replace as necessary.

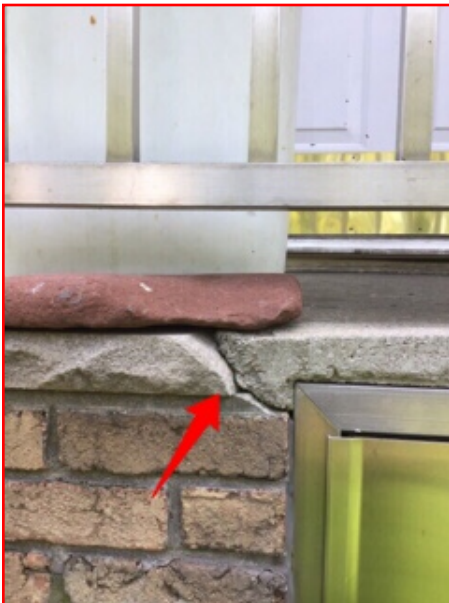
Figure 6-1

3) The entrance to the 2nd floor apartment concrete steps are in marginal condition as some of the concrete has begun to crack and deteriorate, especially on landing. Recommend hiring a qualified mason to repair as necessary so water and ice do not penetrate into the cement blocks and cause further damage.

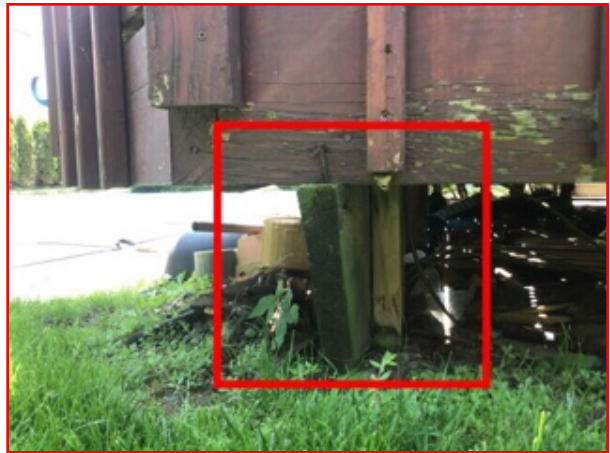
Figure 9-2

5) The hand and guard rails of the deck are in unsafe condition. The balusters are not spaced properly and are more than 4" apart which is a safety issue. The 2x6 support columns are undersized for this size and height deck. They should be 6"x6" and cross braced for anti swaying and support. Recommend hiring a licensed contractor to further evaluate.

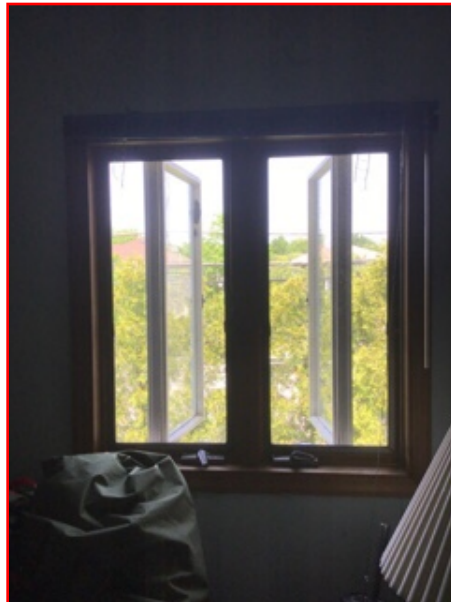
Figure 10-2

6) The windows in the house are older wood windows that do not open and close properly. (with/without external storms/screens attached). Recommend hiring a qualified contractor to replace with energy efficient thermo pane vinyl windows as necessary. On day day of inspection notice that all lintels on windows need to be sanded and painted to prevent deterioration. Recommend hiring a licensed contractor to further evaluate.

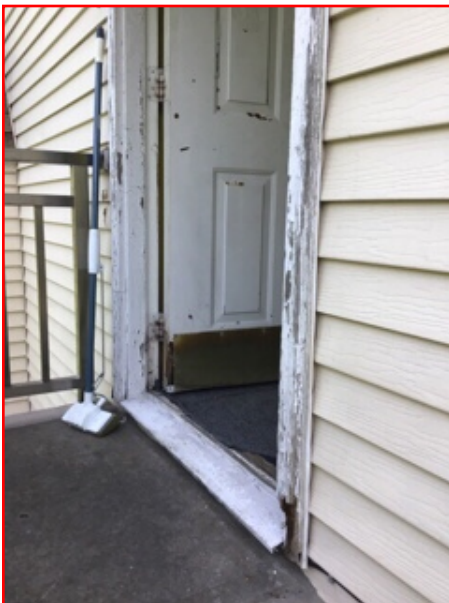
Figure 11-1

7) The second floor entry door is in need of repair as there is wood damage and it needs to be repaired or replaced. Recommend hiring a qualified contractor to assess and repair as necessary.

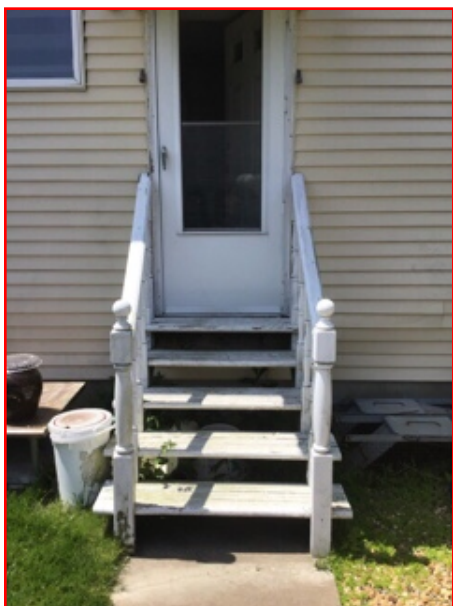
Figure 12-1

8) The rear steps are in an marginal condition as they are loose and wobbly. Signs of deterioration. Recommend hiring a qualified contractor to assess and repair as necessary.

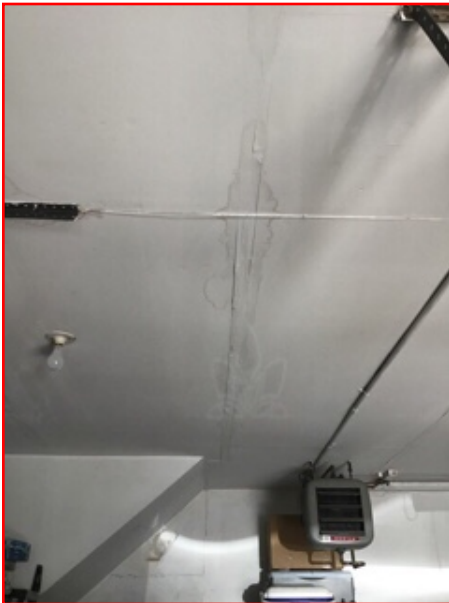
Figure 17-1

11) Ceiling in garage has old water stains. Taping and Sheetrock joints have separated. Recommend hiring a licensed contractor to repair.

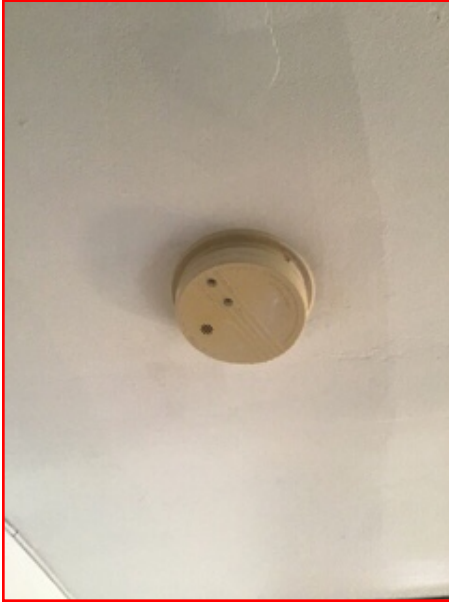
Figure 28-1

16) Smoke and carbon monoxide detectors are important safety devices designed to save lives. It is always recommended to install new detectors when moving into a home if they are 9 volt battery operated (not hard wired systems).

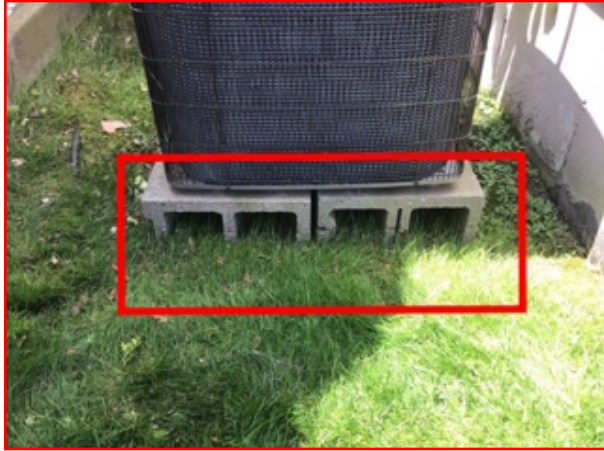
Figure 30-5

17) The exterior compressor unit is showing signs of age and is rusted. The refrigerant line installation is worn and frayed and should be replaced. The cinderblocks need to be replaced with a concrete pad. Recommend having a licensed HVAC company come check the exterior condenser unit and replace insulation on the refrigerant line. Unit was not working on day of inspection.

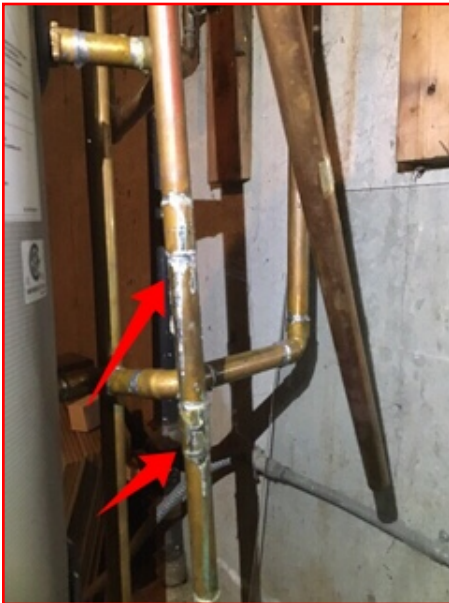
Figure 32-1

18) On day of inspection signs of corrosion are visible on the supply lines of the hot water tank. Recommend hiring a licensed plumber to further evaluate.

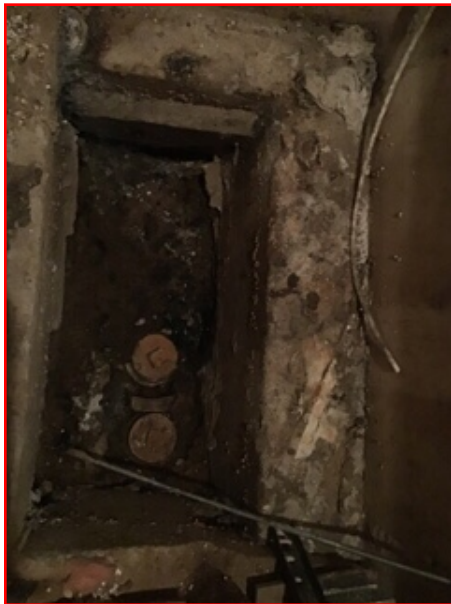
Figure 33-1

19) The enclosure of the p-trap in the basement shows signs of a mold like substance. Recommend hiring a licensed mold contractor to evaluate.

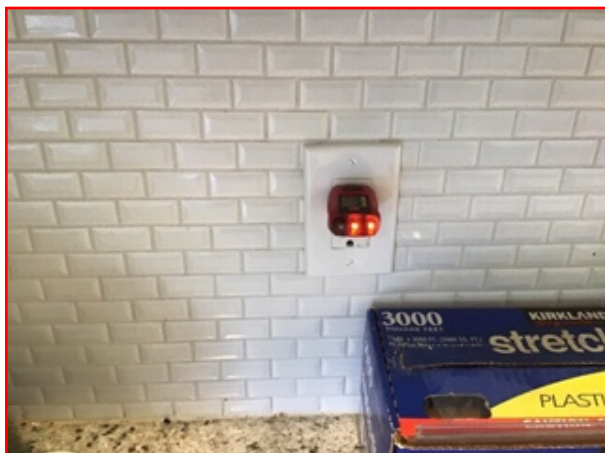
Figure 43-1

23) The outlets in the kitchen counter top area are not GFCI protected and this is a safety hazard. Recommend hiring a licensed electrician to replace all outlets within 6' of the sink with GFCI outlets.

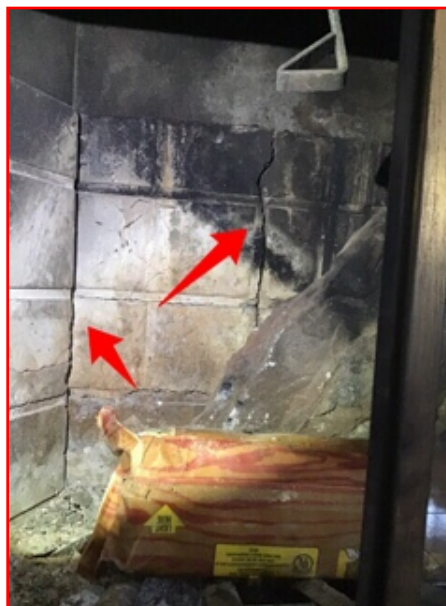
Figure 45-2

24) The fireplace is in poor condition with cracks and missing mortar in the fire box. It is ALWAYS recommended to have the flue inspected and cleaned prior to use. Recommend hiring a qualified mason or chimney contractor to assess and repair as necessary.

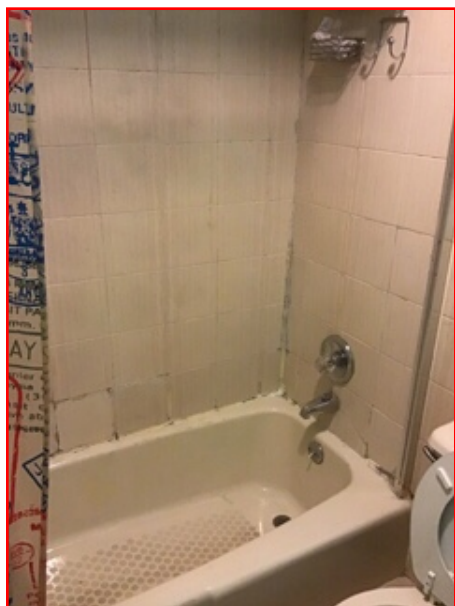
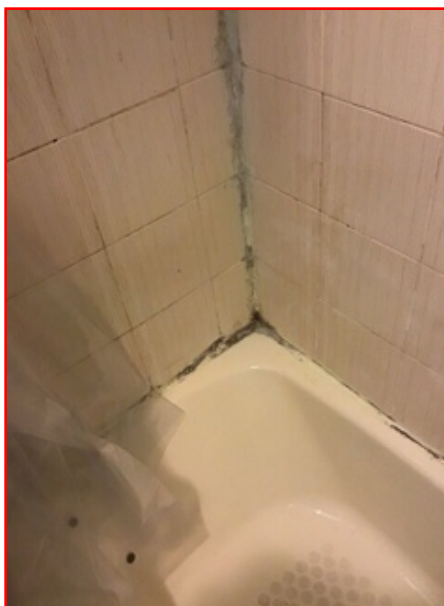
29) There is grout missing in the tub/shower. Also cracked tiles were noted. Recommend hiring a qualified contractor to re-grout and replace cracked tiles as necessary to prevent water from getting behind the tiles.

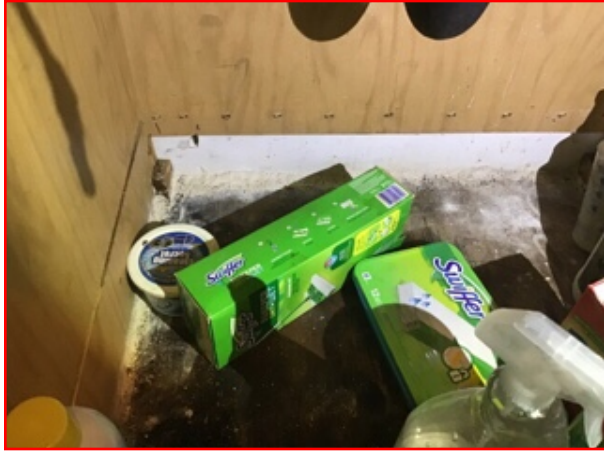
Figure 59-1

31) On day of inspection noticed possible mold like substance under kitchen sink. Recommend hiring a licensed mold inspector for further evaluation. Also, noticed possible mouse droppings under sink. Recommend hiring a licensed exterminator for further evaluation.

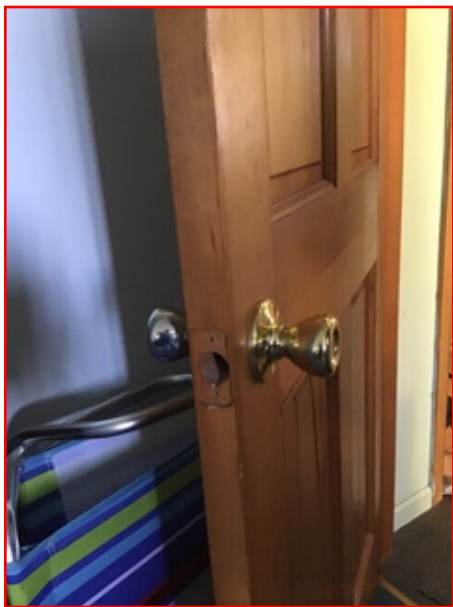
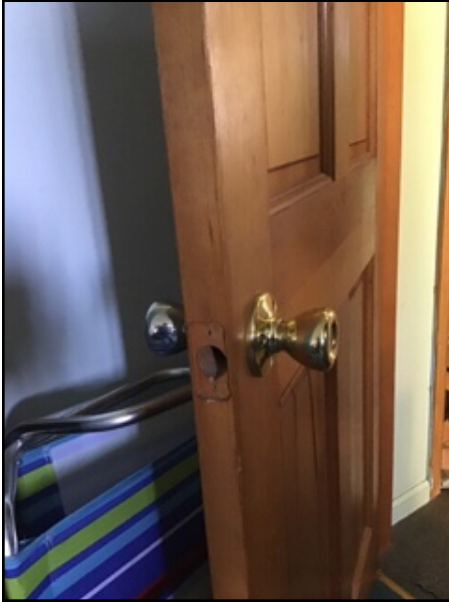
Figure 64-1

The interior doors have damaged handles or knobs. Recommend hiring a licensed contractor to repair or replace.

34) The interior doors have damaged handles or knobs. Recommend hiring a licensed contractor to repair or replace.
